SAFETY! ALERT!

Hired EWP Detached from Ute tow ball

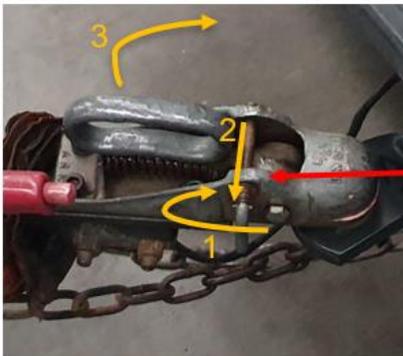
- The retaining spring of a hired EWP was defective/broken. The spring holding the locking pin in position on the coupling is an integral part of stopping the EWP from jumping off the tow ball.
- Although in place when leaving the hire center, the defective spring/pin worked its way out of its retaining slot.
- This then rattled clear across the coupling handle mechanism and enabled it to lift up and disengage off the tow ball.

Spring had lost its tension and allowed the pin to rotate (#1) and slide back (#2), allowing the handle to lift up under load (#3).

- Poorly maintained trailer coupling by Hire company.
- Driver failed to pick up that the coupling had a defective spring on the retainer pin that keeps the handle in the down position/locked onto the tow ball fitting.

- When picking up hire equipment, all components need to be carefully inspected before use.
- Where possible, limit the length of the safety chain to minimise movement of the EWP if it detaches from the tow ball.

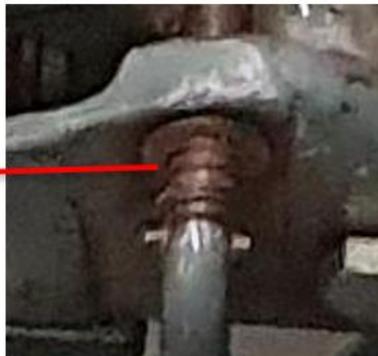
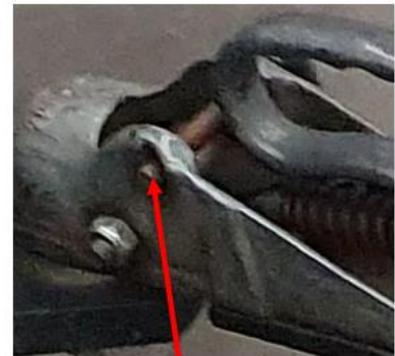
Normal retainer slot that relies on the spring tension to hold the locking pin in position.
