17 March 2021  
 Maximo Reference: 129512

# ENVIRONMENTAL ALERT

## Collapsed Oil Containment Tank Leak

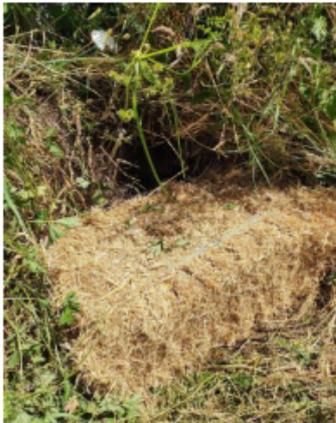
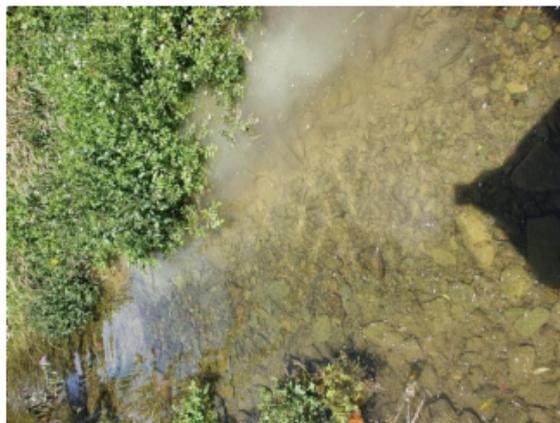
As part of the R7 decommissioning project, the oil containment tank was collapsed and backfilled with hard fill by the civil contractor. Subsequently it was noticed that some water and silt was flowing down the driveway and into the stream, creating an environmental issue.

The tank water had been tested and found to have very low oil residues. The correct action, in this case, would have been to run all the water through the oil plate separators before discharge.

Instructed civil contractor to stop work and implement hazard management measures to prevent more run-off.

Hay bales were laid on the edge of the stream to prevent run-off, and a small dam of hay bales was put into the stream to prevent silty water from flowing downstream. If available, a Matsorb sock is the preferred method to capture light oils that are present in or floating on water.

The Civil Contractor was instructed that in future they are to ensure all excess water has been pumped from the tanks before they are collapsed.
