Lessons Learnt – LL206

Uncontrolled Air Blowout

Incident	Description		
Event Date: 25/05/2021	Time: 15:10	Location: HEN-MPE-STR 243	NP Ref. / External Ref.: INV # 7989 ; Maximo: 131621
What Happened:	<p>A contractor was on site to perform grillage repair works. They had constructed a pipeline approximately 230m from the position of the compressor to the tower for pumping concrete into the foundations. Once the concrete pouring was completed the contractor began the Air Blowout process to clear the lines. With approximately 100m of line to go the operator of the compressor noticed the employee that was walking the line was moving faster and immediately began dumping air to slow the flow down.</p> <p>Unfortunately, it was not enough to stop the stored energy and product in the hose. The hose became uncontrollable; the two employees at the foundation end tried to remove themselves from the area in, in doing so one of them tripped and hit his head on the formwork sustaining a minor cut to his head (figure 1)</p> <div data-bbox="459 1077 1393 1736" data-label="Image"> </div> <p>Figure 1: Re-enactment photo where IP was when he struck his head on the steel formwork trying to get away f

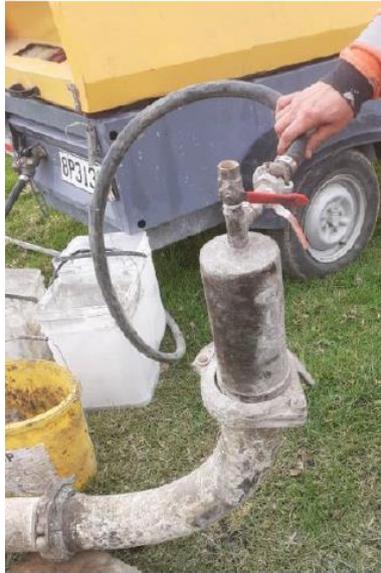
<p>Figure 2: Photo of 3-inch bleed valve onsite</p> <p><i>Design – Inadequate design/setup for the pump and blowout procedure resulting in exposure to hazards</i></p> <ul style="list-style-type: none"> • Air dump valve was inadequate for the pump and blowout process. The valve was 3 inches and should have been 5 inches. This would have likely prevented the build-up of stored pressure (figure 2) • The length of pipeline needed to be reduced to reduce the stored energy factor • A better system of clearing one slump of concrete before introducing next slump should have been done in 3 stages instead of the 2. • The contractor walking the line was able to communicate with the employee at the foundation end, but the operator of the compressor could only monitor visually, he did not have any radio contact.
<p>The important things you should remember about this:</p>	<ul style="list-style-type: none"> • Pumping at this distance (230m) was at the upper end of the pumping system capacity • Because the pumping distance was over 200m water is usually used to blow/clean out the line with the water recovered by a slurry truck system. Due to the steepness of the slope a slurry truck system was not available. • In this instance a hole should have been dug with the excavator to dispose of the concrete slurry, and the concrete hose secured to the excavator bucket to avoid people coming into the capacity with the vibrating end of the pipe.

<p>What you must do in the future OR What will happen next:</p>	<p>Risk Management</p> <p>Although the highest risk of the day was recorded on the risk assessment and discussed with the team on site at the time, the pump operator who arrived later on did not sign on to the risk assessment.</p> <p>The highest risk of the day was the blowout process. The crew should have stopped, discussed required controls and ensured they were in place prior to proceeding.</p>
<p>SM-EI Reference / Hazard Register ID:</p>	<p>Concrete Pumping Health and Safety Guidelines NZ – Section 5 Operation</p> <ul style="list-style-type: none"> • The hose-hand should be able to communicate with the pump operator at a distance • If compressed air is used to clean the pipeline; the following safety precautions apply; <ul style="list-style-type: none"> ○ The air entry point to the pipeline is to be fitted with <ul style="list-style-type: none"> ○ A large diameter discharge air ball valve, to allow de-pressurisation (venting) of the line before removal ○ A pressure gauge, to show the air pressure in the pipeline.
