SAFETY! ALERT!

Project Civil Works Affects Substation Earth Grid Integrity

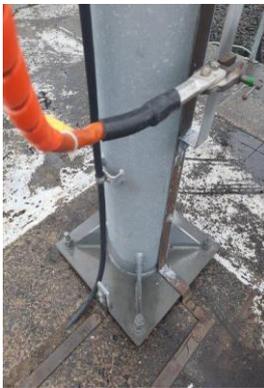
Typical temporary earth tail clamp connection.

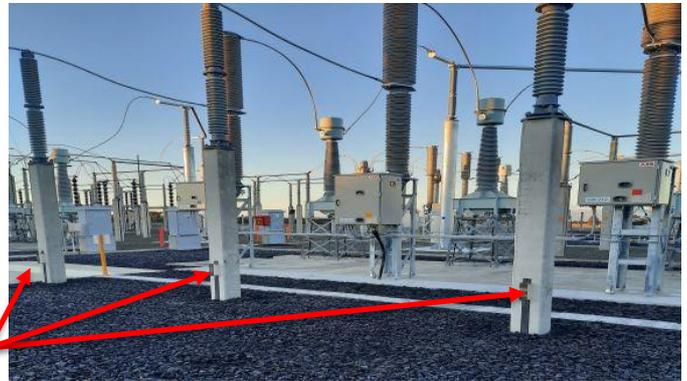
Following a major project at Naseby substation, routine earth grid maintenance testing found that multiple temporary earthing points were no longer bonded to the main station earth grid and were effectively “floating”.

Temporary earth tail clamp connection points that had high resistivity to the rest of the substation earth grid.

The demolition works unknowingly broke some of the earth grid connections between the 220kV and 33kV sections of the switchyard.

- Informed SDM of failed test results.
- Tagged temporary earth points as ‘Do Not Use’ and updated the Temporary Hazard Board.
- Extended testing to the whole substation to identify any further breaks in the earth grid.
- Broken earth grid connections located and repaired.

- High risk electrical civil works, needs Electrical Supervision to install, remove, cut or alter electrical services, cables and equipment. This should be part of a project plan for the work being performed.
- The project should have retested the earth grid after the demolition works.
