Contractor vehicles and MEWP involved in significant Near Miss

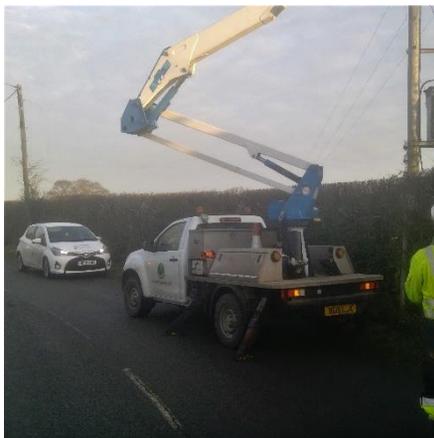
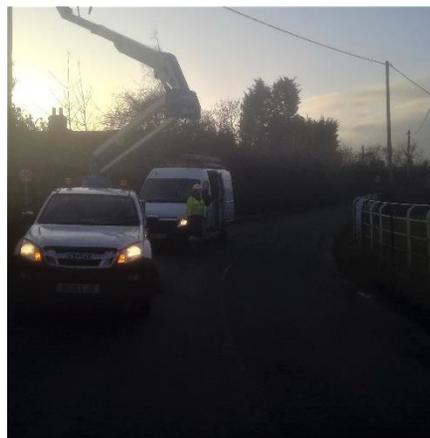
Views from both directions of the 30mph road

On 1st February 2021 an overhead line team from a contractor working on behalf of SPEN in Shocklach Cheshire, were found by representatives of Cheshire West & Chester Council to be working with no traffic management in place on a bend on a road with a 30mph speed limit. One (live) lane was completely occupied by the contractor's vehicles with the boom of the MEWP extending into the remaining live lane.

- Ensure work is planned properly and Setting To Work considerations are understood by everybody.
- Ensure Traffic Management requirements are considered and applied, and there are suitably NRSWA qualified staff on site if required.
- Carry out a risk assessment before starting work utilising the SLAM technique, if conditions or circumstances change then stop work, assess, and manage the risks:

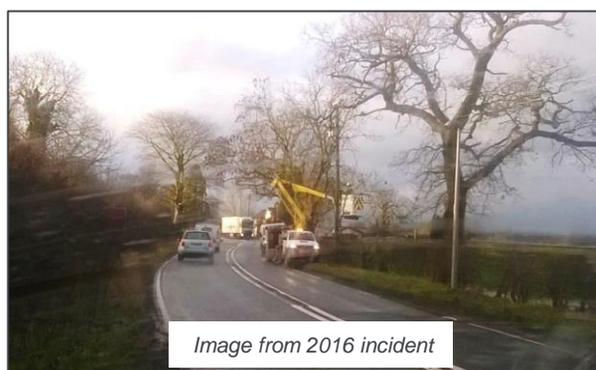
Image from 2016 incident

This incident bore many worrying similarities to a 2016 incident involving a SPEN line team.
