TREE CUTTER INJURY WHILE DISMANTLING A TREE

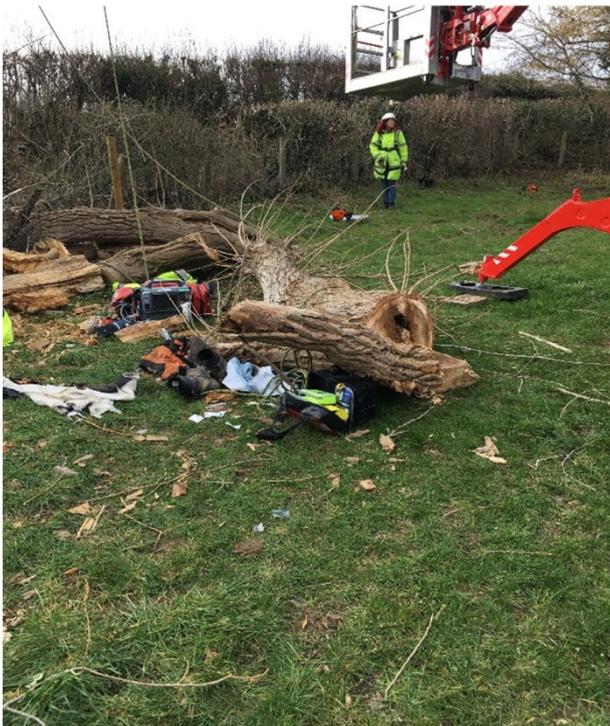
On Monday 1st March, an operative sustained fractures to his pelvis during a tree dismantling procedure. A large limb was being lowered when it made contact with one of the operatives working on the ground.

Part of the trunk of a decayed tree was being cut and lowered in a controlled manner using ropes and rigging. The section being lowered was swung to avoid it being lowered on to a hedge, as it landed on the ground, the operative controlling one of the ropes was pulled towards the trunk and made contact with it, causing the injury.

- Ensure robust method statements are in place to undertake work safely.
- Ensure POWA's are conducted correctly and a PiCOS is appointed.
- Ensure the working party fully understand the procedures that are taking place and the role that they are taking in the procedure.
- Drop/fall zones are established and maintained.
- Communication between members of a team on site are structured, controlled and maintained at all times.
- Emergency arrangements are accurate and recorded on the POWA.
