# Safety Restriction

# Failure of Arteche CH-123 110 kV CT

Issuing Authority:	Network Assets
Content Owner:	Crowley. Bryan (ESB Networks)
Document Number:	DOC-040821-GXO

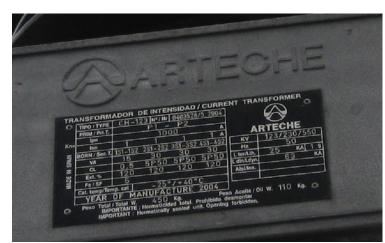
On 22<sup>nd</sup> July 2021, in Drumkeen 110 kV Station, an Arteche CH-123 110 kV Current Transformer (CT) ruptured. This resulted in porcelain shattering and subsequent damage to other equipment in the station. There were no staff in the station at the time of the failure. Replacement of the remaining Arteche CH-123 CT's in Drumkeen station is planned and underway. See shield incidents 84786 and 84691

Figure 2 Arteche CH-123 110 kV Current Transformer Name Plate
