**FIRST ALERT****Health & Safety****Northpower**

Subcontractor hit de-energised 11kV cable with digger (FA051)

Incident	Description		
Event Date: 3/08/2022	Time: 08:32 AM	Location: Atiamuri	
Investigation Status:	On-going		NP Reference: INV10354 Maximo:145924

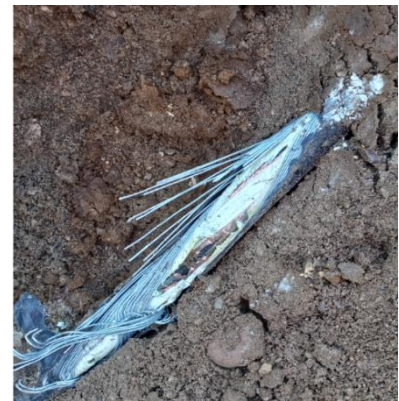
When work was about to start the operator inspected the bulldozer and found a defect. He made a decision to use the excavator that was on site to complete the works. The incident occurred when the operator made the decision to dig a hole to bury rocks instead of stockpiling them for removal later in the day as per the requirement/process. Unaware there was an 11kV underground cable he dug the hole and struck the de-energised 11kV cable.

Actual potential outcome was no harm to the operator because the cable was de-energised. However, the damage to the cable was significant, with damage to the outer 5 layers of the cable, down to the copper tape screen. Extensive repair work was needed to get the cable back in service.

1. Do not, under any circumstances dig holes to bury debris. All debris must be removed from site
2. The operative on site had not been supplied with cable records
3. Any ground disturbance requires a permit to dig.
4. For any change on site whether it be personnel or scope the risk assessment must be updated and communicated

Supporting References:	SMEI 2.1204 Work in Excavations (e) Care shall be taken to avoid damage to underground services during any excavation / land disturbance. i. use of plans and marking out ii use of cable and pipe location devices
For more information:	Janine Wagstaff – Northpower HSQE Advisor Central
