Plastic ducting pipe dropped from height into pit bottom.

Hurst headhouse LPT2

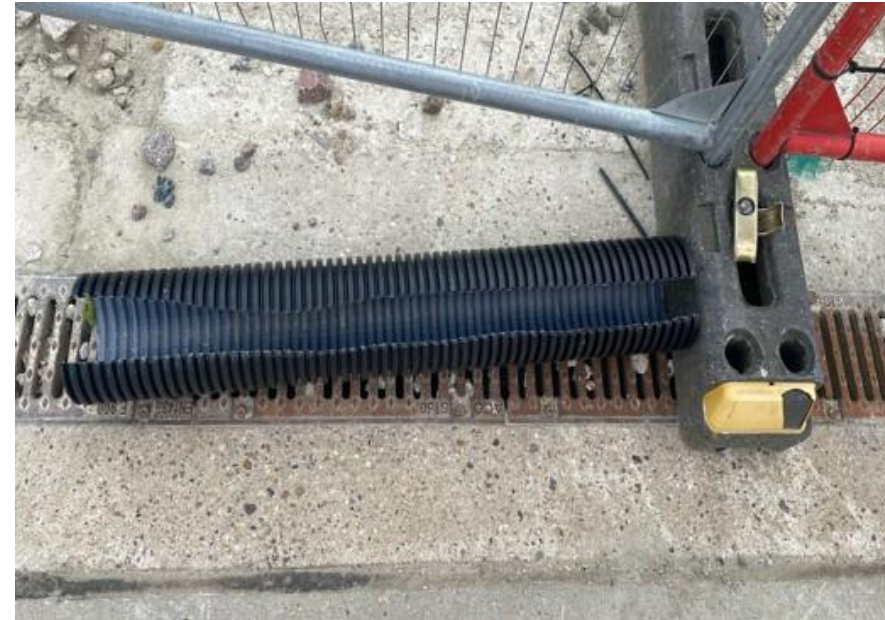
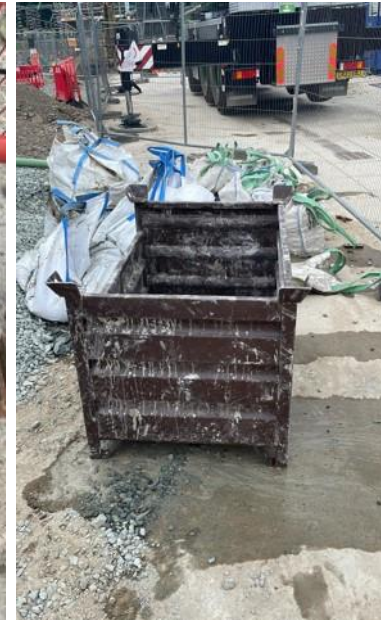
The Principle Contractor (PC) were lowering a stillage containing plastic split ducting into the shaft on the Eltham side.

The stillage was being lowered with the use of a 60t crane. On completion of the lift it was established that one of the sections of ducting had come out of the stillage and had fallen to the pit bottom.

There was a full exclusion zone in place at the pit bottom. No injuries to persons or equipment damage.

The incident was reported and the area was checked and made secure. A Safety stand-down took place on 10th June and an incident investigation is underway.
