# Action Notification

## Riganti clamp slipping

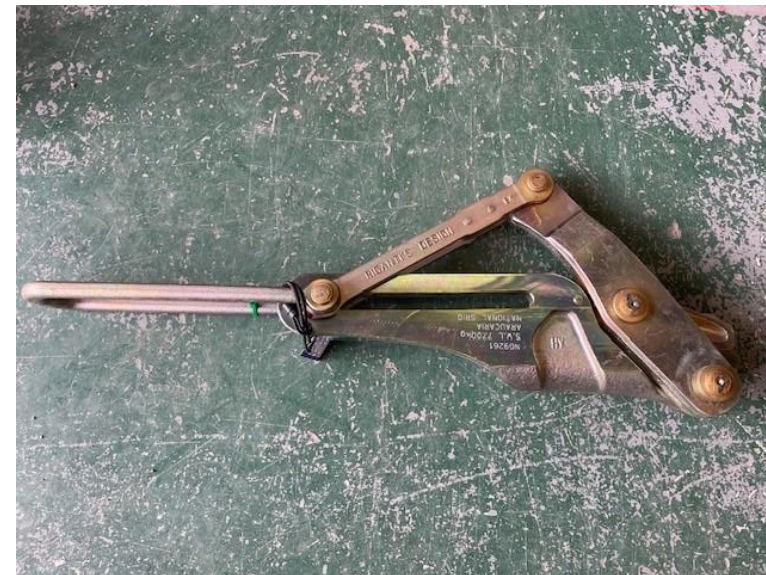
Whilst carrying out an Overhead Line apprentice training course, the Riganti clamp being used to take the line weight was noticed to be slipping as the weight was being taken. The trainer supervising the apprentices up the tower, stopped the work and had the apprentices reduce the weight taken to investigate. The trainer was happy that the clamp had been fitted correctly and therefore took the decision to stop that aspect of the training course. The clamp that slipped was quarantined and the training course proceeded on a different conductor using a different Riganti clamp. The same issue occurred on the different conductor. The course was stopped and the 2<sup>nd</sup> Riganti clamp was quarantined. Both Riganti clamps were new and being used for the first time.

- The affected Riganti clamps are being sent back to the supplier for further testing
- All Overhead Line teams have been contacted by the equipment and procedures engineer to see if they have had any issues and reminding them to be vigilant when using the new Klein/Riganti clamps.
