Excavator partially slid on the existing concrete slab into an open excavation

BRIDGWATER 275KV S/S:
WESTONZOYLAND ROAD,
BRIDGWATER, SOMERSET TA7 0HZ

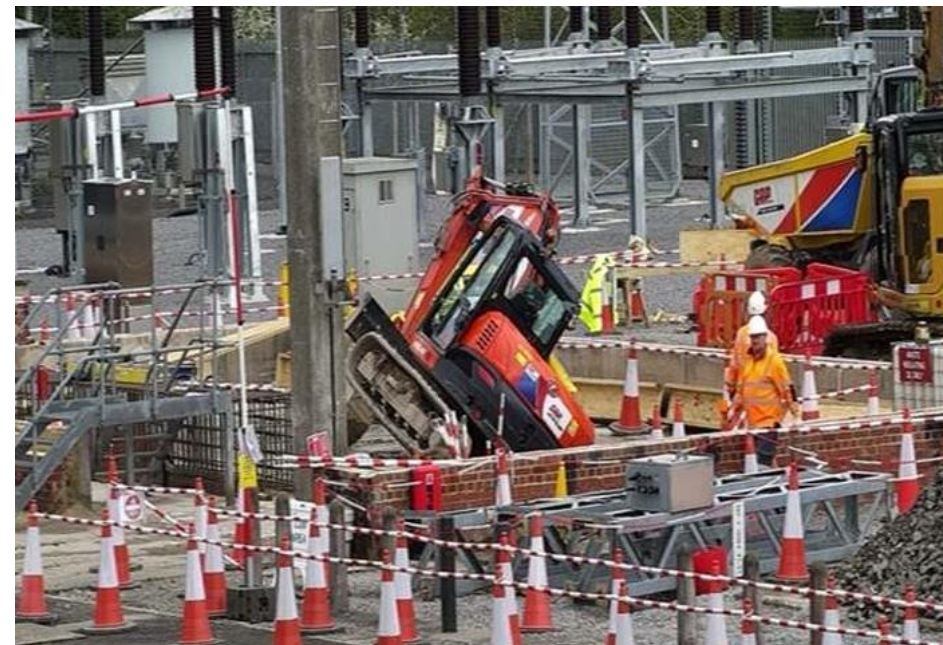
Whilst completing an excavation within an existing transformer bund for additional piles/reinforcement, an 8T 360 Excavator partially slid on a existing concrete slab into an open excavation (8m long x 1.3m wide x 1.0m deep).

There was a banksman and supervisor in attendance, both being outside the machines exclusion zone and in the line of sight of the operator. The area was made safe and an initial inspection for damage was conducted, the workforce were stood down and relevant investigative actions were started (drug and alcohol tests, witness statements etc.) and the excavator was moved clear of the excavation.

Operator was reported to have been wearing his seatbelt and no injuries were reported at the time of the incident.
