An engineer fell backwards whilst pulling cables within a cable trench, resulting in a back injury.

Location/Site:
Mannington 400kv Substation

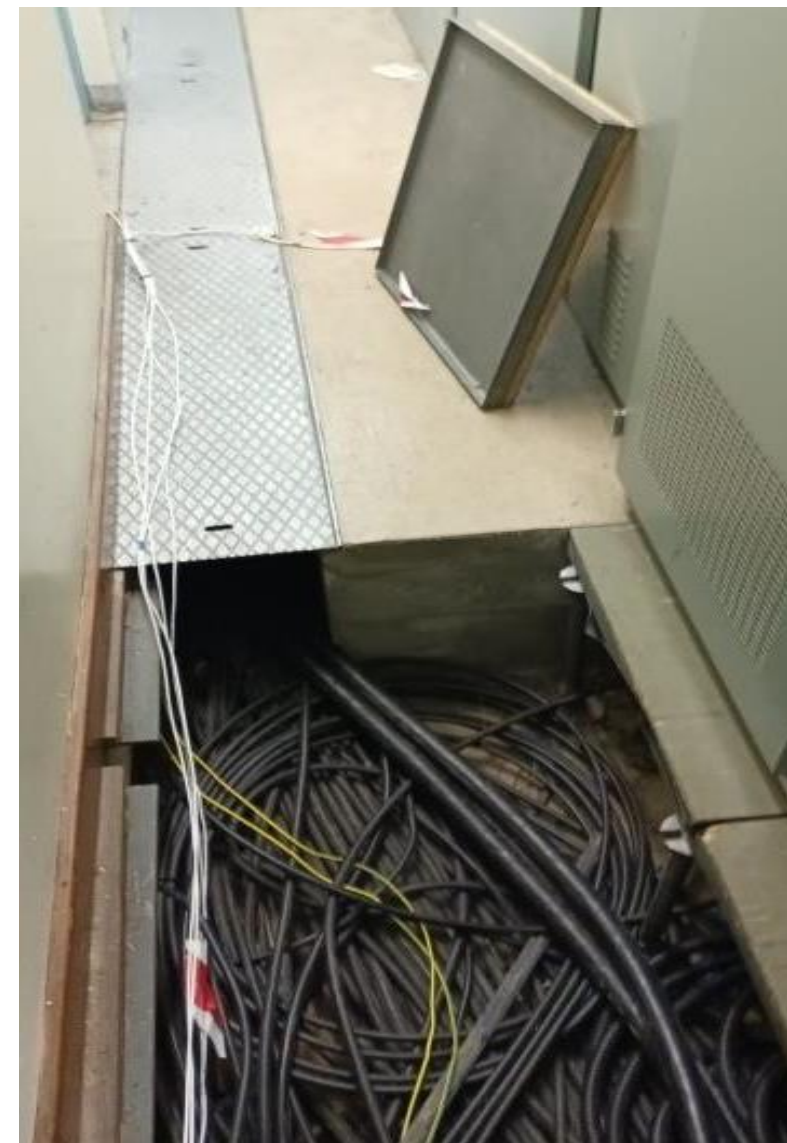
While removing redundant cable from a cable pit, two engineers were pulling the cable out, both holding the cable and a strap attached to the cable by means of nut and bolt.

In order to access the pit, the covers were removed along with two square floor tiles which are chipboard / metal.

The pit cover was leant against a wall close to the pit opening while the engineer sat on the floor with his feet in the cable trench.

The excessive force applied to remove the cable resulted in a swift release of the cable which caused the engineer to fall back against the tile that he had placed behind him resulting in an injury to his back.
