# SHE ALERT

## Tower Fall

Date of incident	26th February 2024		Directorate	Operations SEPD	
Region	Works Delivery	Location	Alton	Classification	Dangerous Occurrence - HiPo

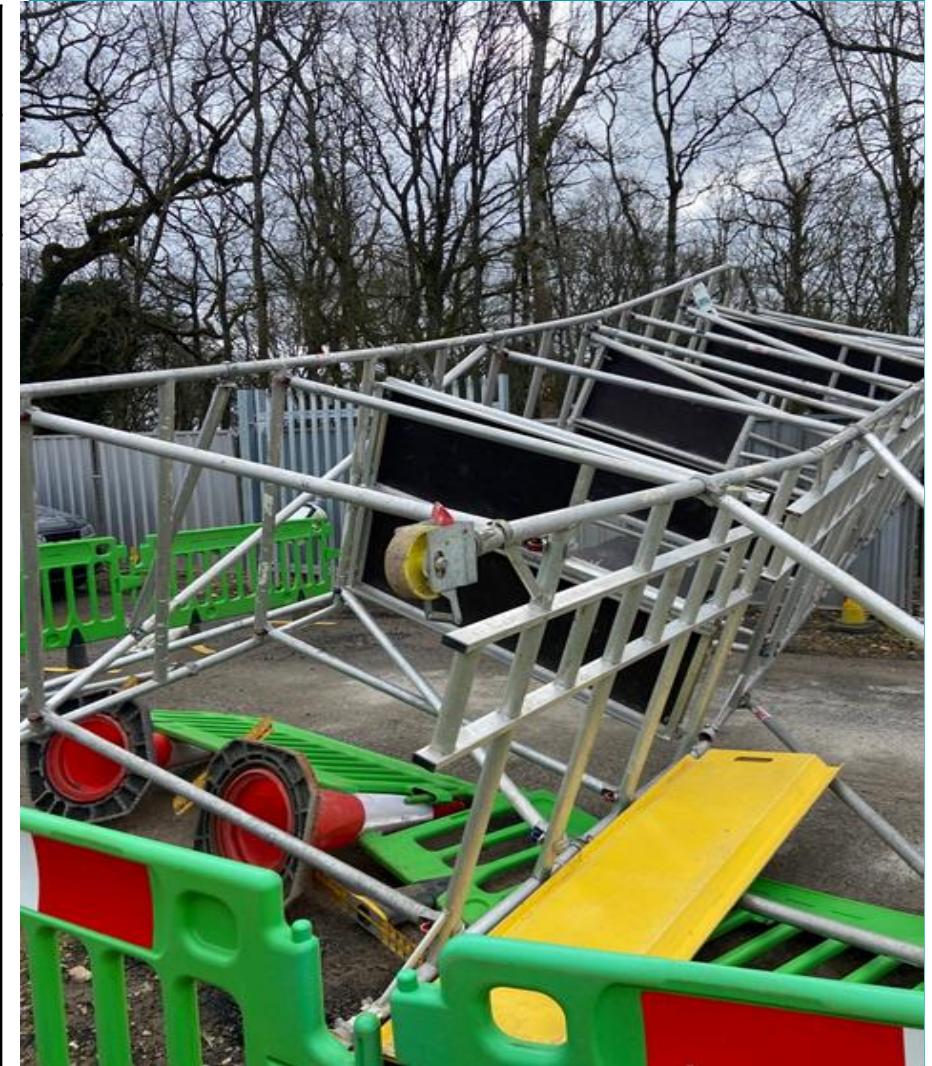
SSEN-D colleagues erected a scaffold tower at one of our sites to facilitate some communications. After the scaffold had been erected for a week, there was a period of inclement weather and as our Subcontractor was opening the gate early on Monday morning the tower fell approx. 2m from them. Fortunately, there were no injuries and the circumstances around this event are under investigation.

- The requirement for working at height should be assessed in accordance with hierarchy of control – Working at height risk standard RS-SHE-105.
- If scaffold is required, the erection of this must be carried out by a trained and competent persons. Within SSE, the minimum standard is they must hold a PASMA ticket.
- Scaffolding must be inspected on a 7-day frequency.
- When scaffolding is erected, consideration for the time and capability (i.e. wind loading) must be considered and factored in.
- If in any doubt STOP, use your licence. If it's not safe, we don't do it!
