Finger pinched between current transformer steel structure base plate and bolt.

Location/Site:
Bredbury 275 kV substation

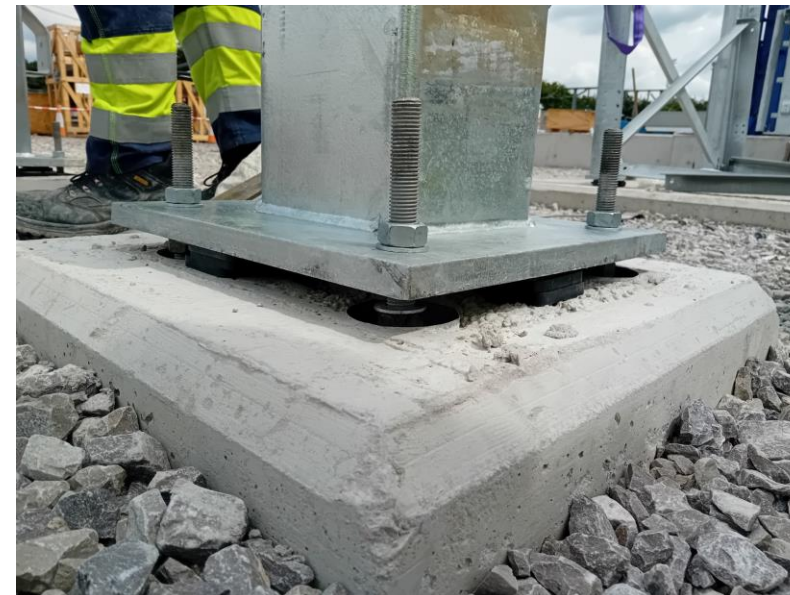
Whilst erecting Current Transformer (CT) structure, the operative's glove became caught between the base plate and the holding down bolt and the operative cut his finger when he quickly removed his hand from the glove on the holding down bolt threads.

The operative received first aid on site and then attended hospital where a steristrip plaster and bandage were applied to the injured finger. The operative returned to work the following day.
