A linesperson was observed unclipped whilst working on an OHL tower.

Incident date: 06/06/2024

ZDA Tower 140

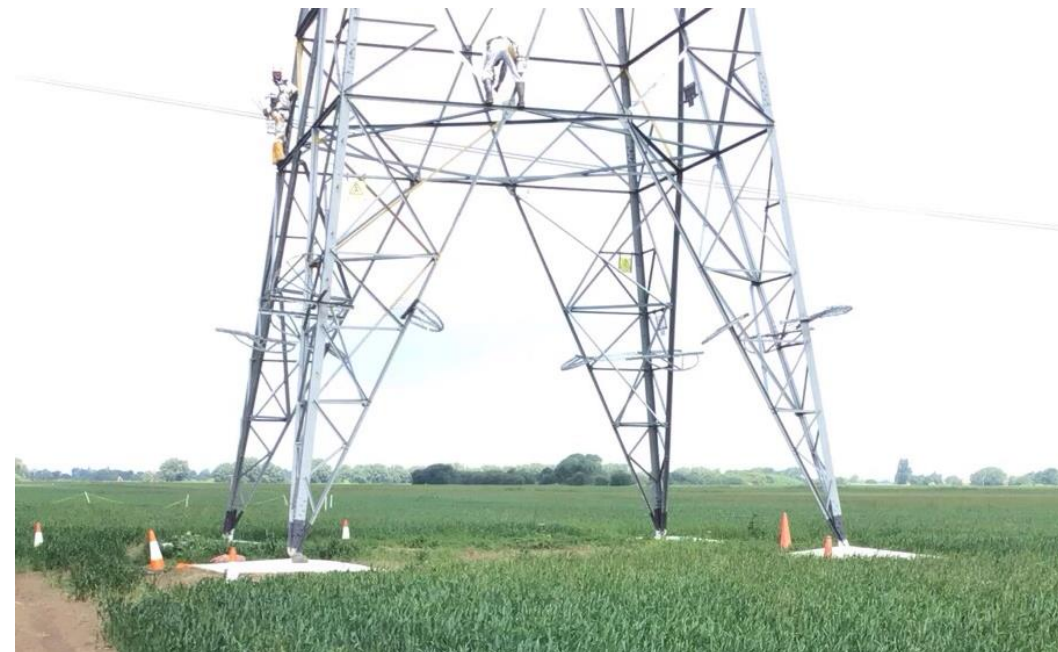
Operatives from CLC (tower painting contractors) subcontracted by Morrisons were painting strengthening steelwork approx. 4m above anti-climb guards.

An operative was observed for a short period of time to be unclipped from the tower when work positioning.

Note: image not of the incident but taken on site visit to the incident location.

The operative was instructed to climb down safely, and work at that site has been stood down pending investigation.
