SHE ALERT

Live 11kV Cable Cut

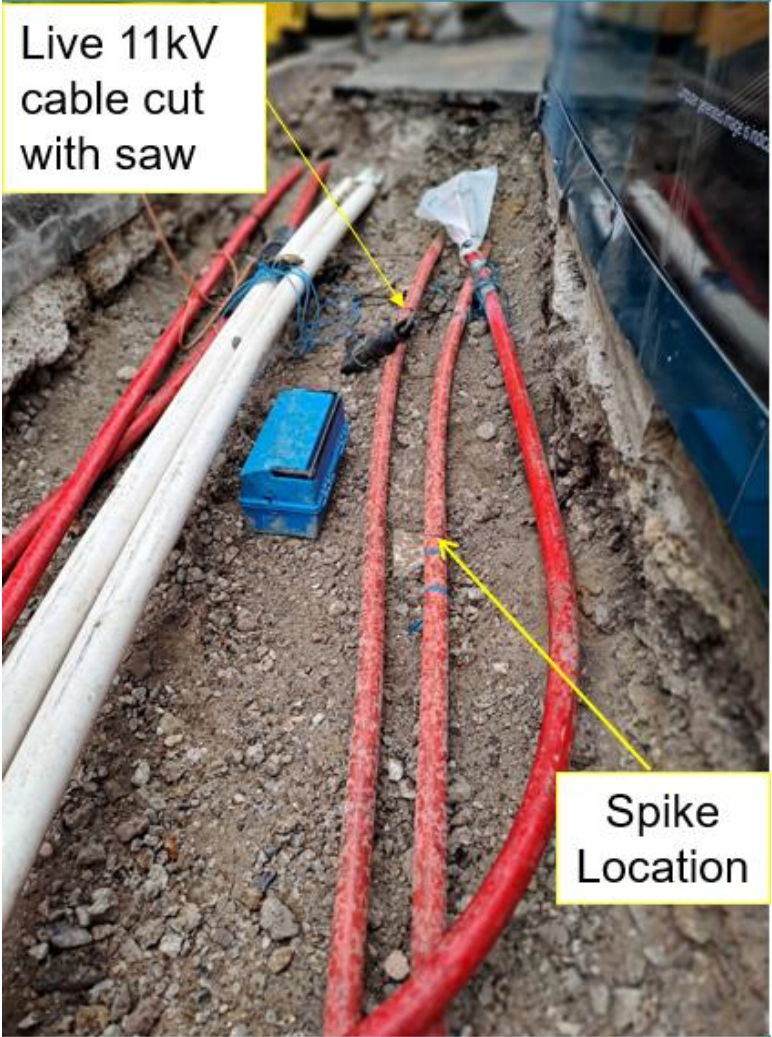
Date of incident which is raised in days	25/07/2024		Directorate	SEPD – Customer Service	
Region	Large Connections	Location	Brentford	Classification	PTBW
What happened ?					
<p>While in the process of installing a new substation in Brentford, West London, SSEN SAP had correctly Isolated, earthed, identified and spiked an 11kV cable under Sanction-For-Test.</p> <p>Contract partner jointer then inadvertently cut through an adjacent LIVE 11kV cable using a reciprocating saw, this caused a flashover to occur and the 11kV circuit to trip.</p> <p>All correct PPE for the task being worn and No injuries received.</p> <p>Prior to cutting ANY cables, ensure they are identified by an approved procedure and all other live cables are screened.</p> <p>This is under a full investigations and the learning points will be issued as part of the follow-up Brief.</p>
