SHE ALERT

Fallen Object

Date of incident which is raised in days	04.04.2024		Directorate	SEPD	
Region	CMI	Location	Romsey	Classification	HI-Po
What happened ?					
<p>Staff were in the process of changing the insulators on a 132kV tower, the team had taken down the old insulators and had put in place a new set of insulators, when a pulley block fell 30 meters and struck an operative on his safety helmet. There were no injuries sustained as all members of the working party were wearing their correct PPE.</p> <p>As a reminder, when carrying out work at height please remember these important points:</p> <ul style="list-style-type: none">• Ensure Work at Height Hierarchy is followed.• Ensure Exclusion zones are in place.• Ensure you are wearing the correct PPE at all times.• Ensure good communication with all members of the team, if this is not possible then stop works.• Ensure equipment is inspected and defect free.

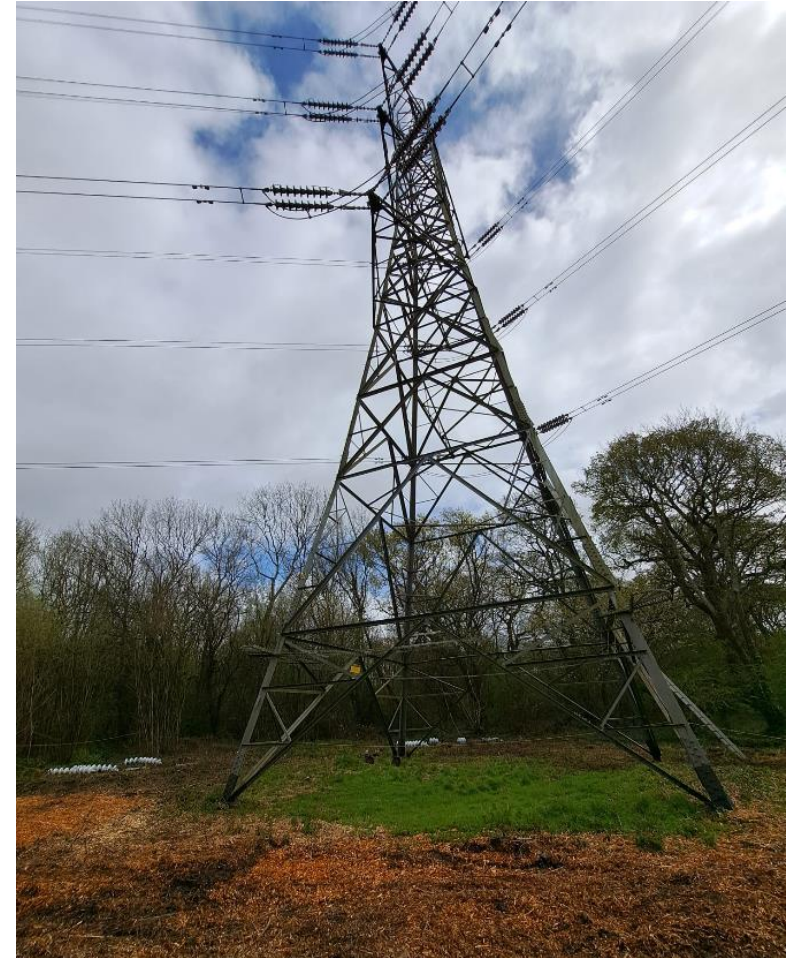
Staff were in the process of changing the insulators on a 132kV tower, the team had taken down the old insulators and had put in place a new set of insulators, when a pulley block fell 30 meters and struck an operative on his safety helmet. There were no injuries sustained as all members of the working party were wearing their correct PPE.

- Radio communication has always been available as part of the communication plan, however, were not used on this day. This has now been mandated and added to the new OHL Tower Manual. The radios are fully tethered to the operative working at height.
- The team have trailed head set radios as a way of improving the two-way communication.
- We have ensured that a working supervisor (lead person) is discussed and detailed on the risk assessment each day.
- The OHL Tower contractor's staff have now been put on the immersive training course.
- We have enhanced the current exclusion zone procedure to fall in line industry standard across the UK and updated our procedures, which have been included in the new Tower line manual WI-NET-CAB-168.
- The pulley blocks of this type where suspended while we carried out this investigation (and this was shared with our Transmission colleagues).

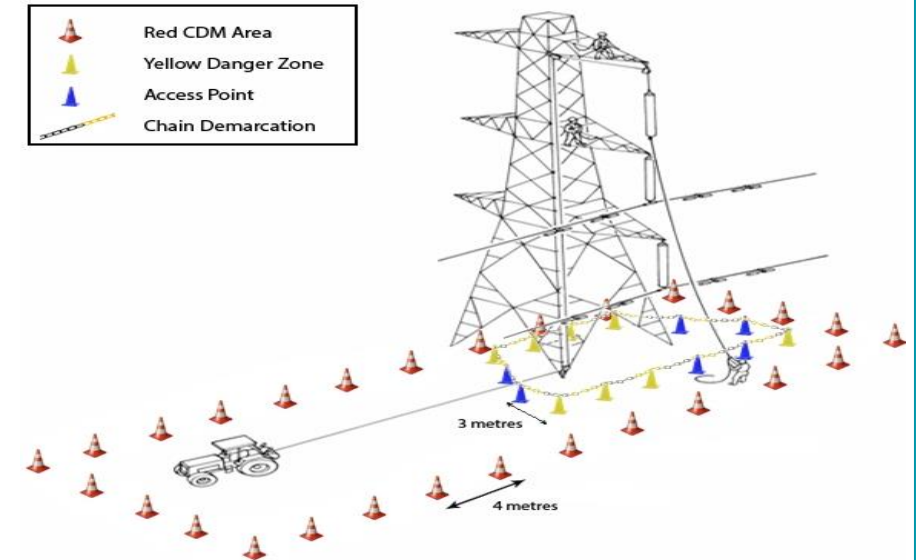
- A roller block fell from height and struck the operative

- The weather and environmental conditions contributed to a noisy environment.
- A rope needed to be secured, as it was not previously secured, could have posed a danger in the wind conditions.
- The roller block used was not secured effectively to prevent it from falling. Type used was a hook and gate securing mechanism which is common in the industry.

- A lapse of concentration has caused the operative to enter the exclusion zone while work at height was ongoing.

- We have enhanced our Tower exclusion zone procedure, to follow good practice examples across the industry and updated our procedures in the Tower line manual WI-NET-CAB-168.
- The pulley blocks of this type were initially suspended while we carried out this investigation (and this was shared with our Transmission colleagues). Following the investigation, we believe there was a degree of human factors at play as to how the pulley was deployed and we are fully confident in this type of pulley. We have now reinstated the use of this pulley type and retrained/refreshed all staff how it should be correctly latched.
- All OHL tower operatives have been briefed with regards to their roles and responsibilities and also Licence to Stop
- Before works recommenced on this site the team attended a re-briefing of the works and exclusion zones.
