Safety Action Notification

Pipe Corrosion Beneath Lagging

Location/Site: BISHOP AUCKLAND COMPRESSOR STATION

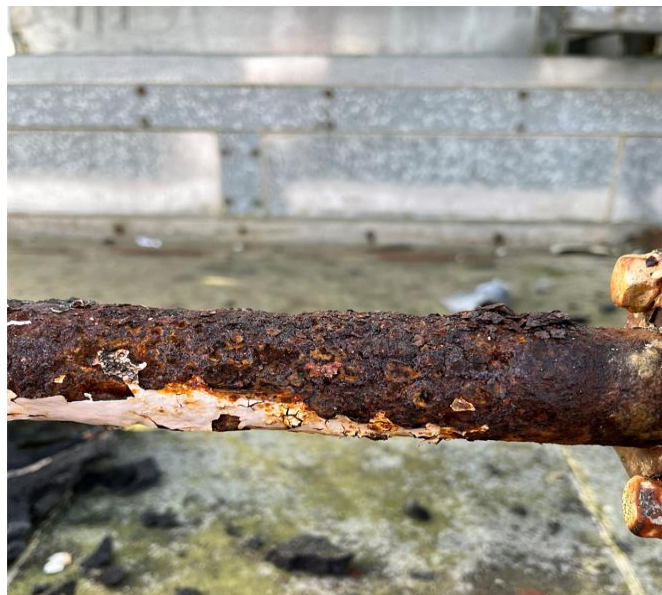
During maintenance, the technician noticed some bad corrosion behind some lagging on the Unit suction valve pressurising pipework.

Corrosion SME was on site later that week and asked to check for an opinion. Advise was to get scaffolding erected to allow good access to the pipework and for lagging to be removed and a further inspection of the pipework carried out. Upon removal of lagging, it was noticed that the pipework was in a very poor state, this was observed on both Units on site.

Asset were informed and sent photographs and asked for a 20% pressure reduction. Due to the poor design of the site, this resulted in the Station requiring to be isolated. Station was ESD and vented down to atmospheric pressure pending a P20 inspection. P20 was carried out a day later and confirmed the corrosion to be superficial. A holding coat was applied to the pipework and the site re-commissioned. Other areas of lagging on the units were also inspected at the time but in good condition.

- Assess whether you have equipment operating in an aggressive environment that could cause a breakdown in corrosion protection for pipe work covered by lagging.
- Assess whether you need to remove the lagging to carry out a corrosion inspection.
