New bus bar arrangement found to be incorrectly installed.

Location/Site:
Hurst 275 kV substation

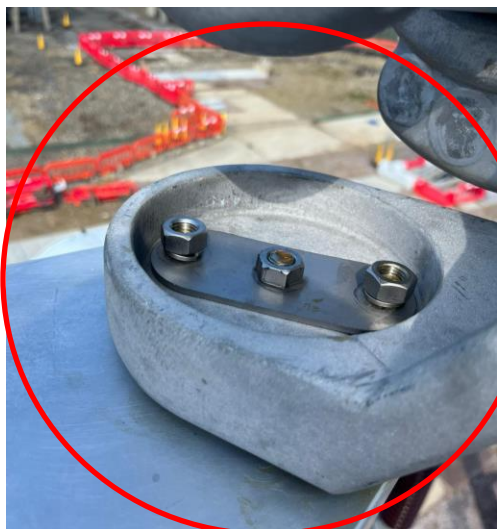
Red phase connection as found, nuts were found hand tight and spring washer not installed on centre fixing.

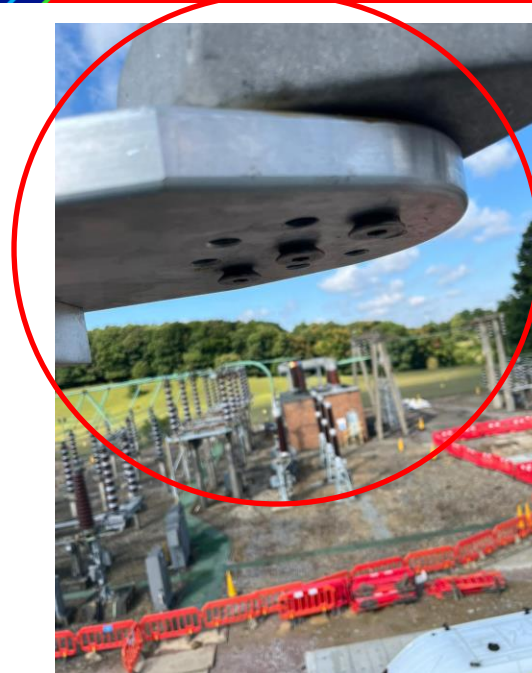
Countersunk fixings installed on flat connection, this palm joint is believed to be installed upside down.
