Whilst escorting a crane from site Gatic covers collapsed

Location/Site:
EAST CLAYDON 400KV S/S:

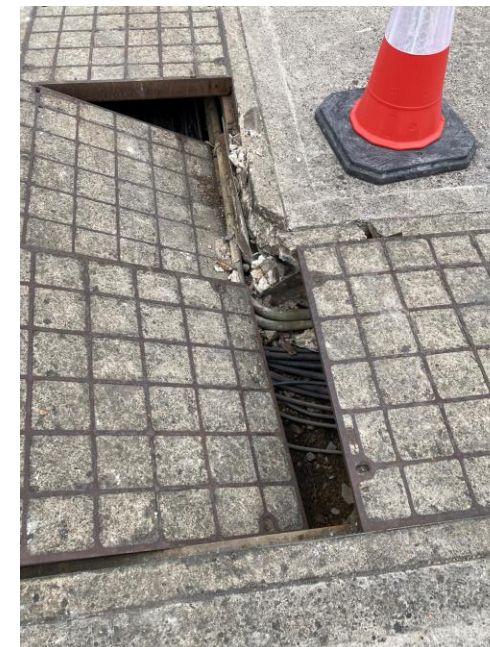
Contractor lifting supervisor from Celtic recycling was escorting a 40 tonne crane off site following the prescribed NSI8 F1 route. The route included transit over Gatic Trough covers and as the rear wheels moved over the trough, two of the Gatic covers collapsed into the trough. No damage to the vehicle or injuries to persons. The collapsed covers came to rest near air pipes, on top of multicore cables.

Previous learning from similar incidents with Gatic covers introduced the requirement to visually inspect them when planning to drive over the covers with a vehicle weighing up to 5 tonnes. This inspection can be carried out without removing the covers.

If a vehicle weighing over 5 tonnes is to be driven over the covers then the covers must be removed and a detailed examination carried out of the covers the trough.
