Safety Action Notification

OHL Training Incident

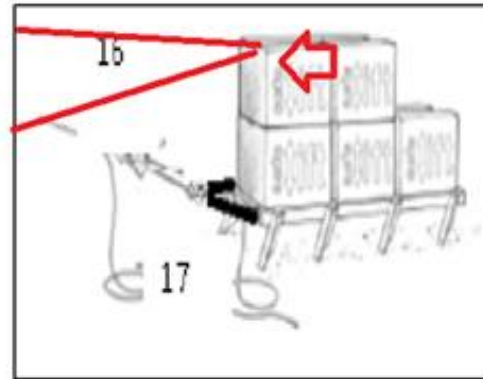
Whilst catching off conductors a 1.5t concrete block fell approximately 1m to the ground after being pulled from a separate block below. No injuries or damage to equipment occurred.

In an attempt to alleviate the manual handling of pulling the slack out of the wire rope by hand, a 2 to1 system was rigged up using the top block as an anchor (as shown in drawing). Upon taking the weight the force pulled the top block from its original position and fell to the floor.

- Stay vigilant when using mechanical advantage systems during rigging activities.
- Investigation to follow, all outcomes and learnings will be shared.
