SHE ALERT

Line of Fire Incident

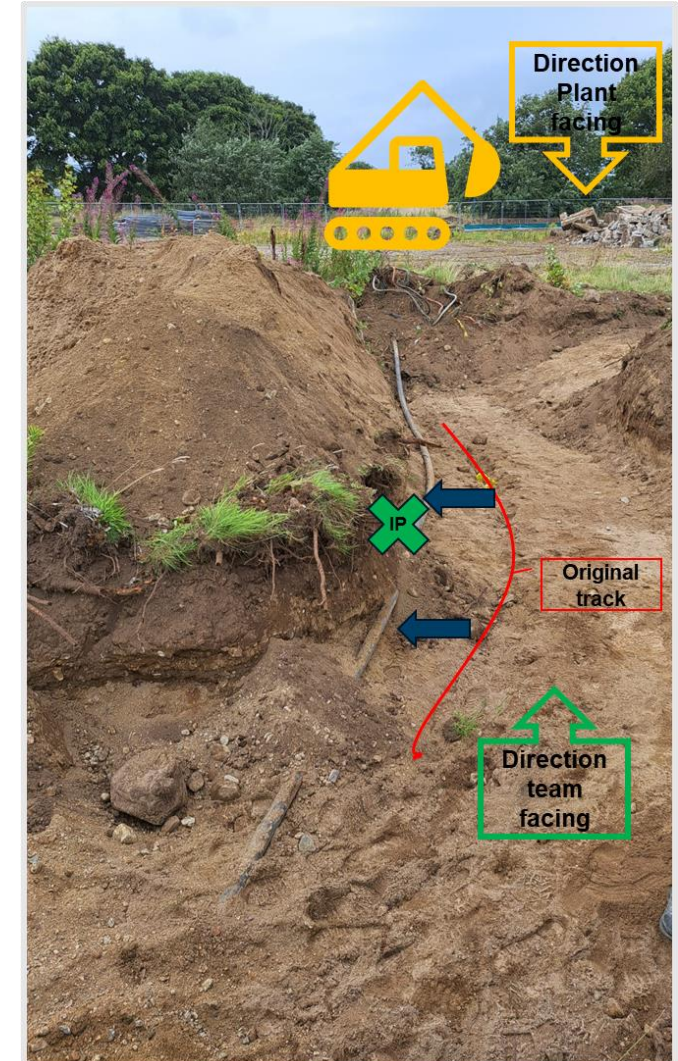
Date of incident	19/08/2025		Directorate	Operations SHEPD	
Region	Caledonia	Location	Dyce	Classification	LTI
What happened ?					
<p>Our Fault Team colleagues attended a construction site to assist a third party that had identified a cable not on the site drawings. Trial holes identified LV cable markings and cable route; with several open cable ends found where an old plant room had been sited.</p> <p>The third party's excavator and hand digging were used to trace back along the cable route. When working in the area where the cable ends were uncovered, the banksman thought they saw the cable move. As the excavator has tracked back the cable has been caught and tightened, moving towards the side wall of the excavation. At this point, our colleague's legs have been caught between the tightened cable and the side of the excavation. The IP was taken to hospital by ambulance as a precaution.</p> <p>As the incident is investigated, we ask all colleagues to consider:</p> <ul style="list-style-type: none"> • Line of Fire – not only do we need to think about our position, we need to consider the unintended consequences of actions that can place us at risk. The shortening of the cable has caused it to follow the path of least resistance/shortest route. • Dynamic Risk Assessment – is important in continuously identifying hazards and action to reduce/eliminate the associated risk. This can help to identify any change in workscopes where we, as electrical experts, risk becoming involved in third party works.
