SHE ALERT Cable Flashover

Date of incident which is raised in days	01/07/2024 15:40		Directorate	SSEN Distribution	
Region	Wessex	Location	Bournemouth	Classification	PTBW

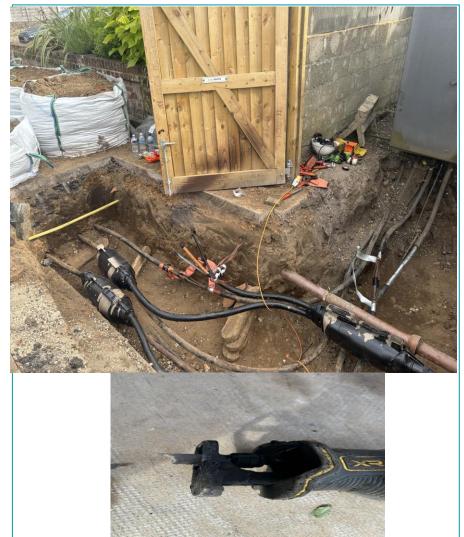
After returning from a break the contract jointer decided that the cable tail was too long and he needed to shorten it to get a better jointing position. He then proceeded to cut the cable with a reciprocating saw without proving the cable dead at the point of work.

The cable was <u>live</u> and our contract partner employee suffered burns to his face and hand, he attended A&E where treatment was administered.

In the interim this is a timely reminder that live jointing techniques Shall be used at all times when operating on the LV network and the appropriate full live working PPE Shall be worn.
