Rapid Incident Notification

Caught in Between

Briarwood Drive - North Tonawanda, NY

NYW Electrical Operations

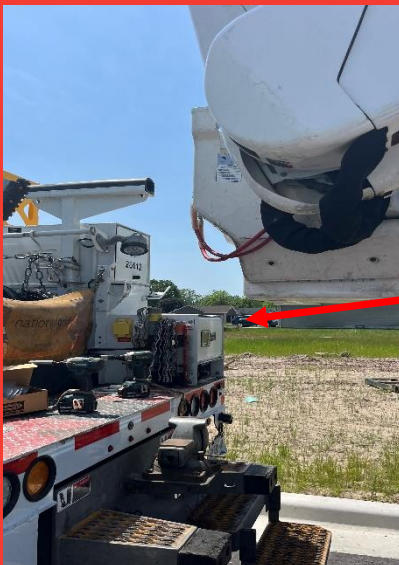
- On the afternoon of May 21st, 2024 an Overhead Line Crew was tasked with placing a pad mount transformer in a new underground residential development.
- Crew makeup consisted of a Crew Leader, Line Mechanic C and two Apprentices
- Crew successfully lowered transformer onto fiberglass pad with the material handler of the bucket truck utilizing the lower controls.
- Employee was standing on the rear step of the bumper operating the bucket when he inadvertently moved the bucket pinching himself at his upper torso between the bucket and the controls.
- All work was deenergized.
- Employee was transported to hospital for evaluation.
- Incident Analysis (IA) will follow.

Upper body caught between bucket and lower controls.

- Maintain situational awareness.
- Understand equipment operation.
- Understand hazards associated with equipment.
