SHE ALERT

MEWP Failure

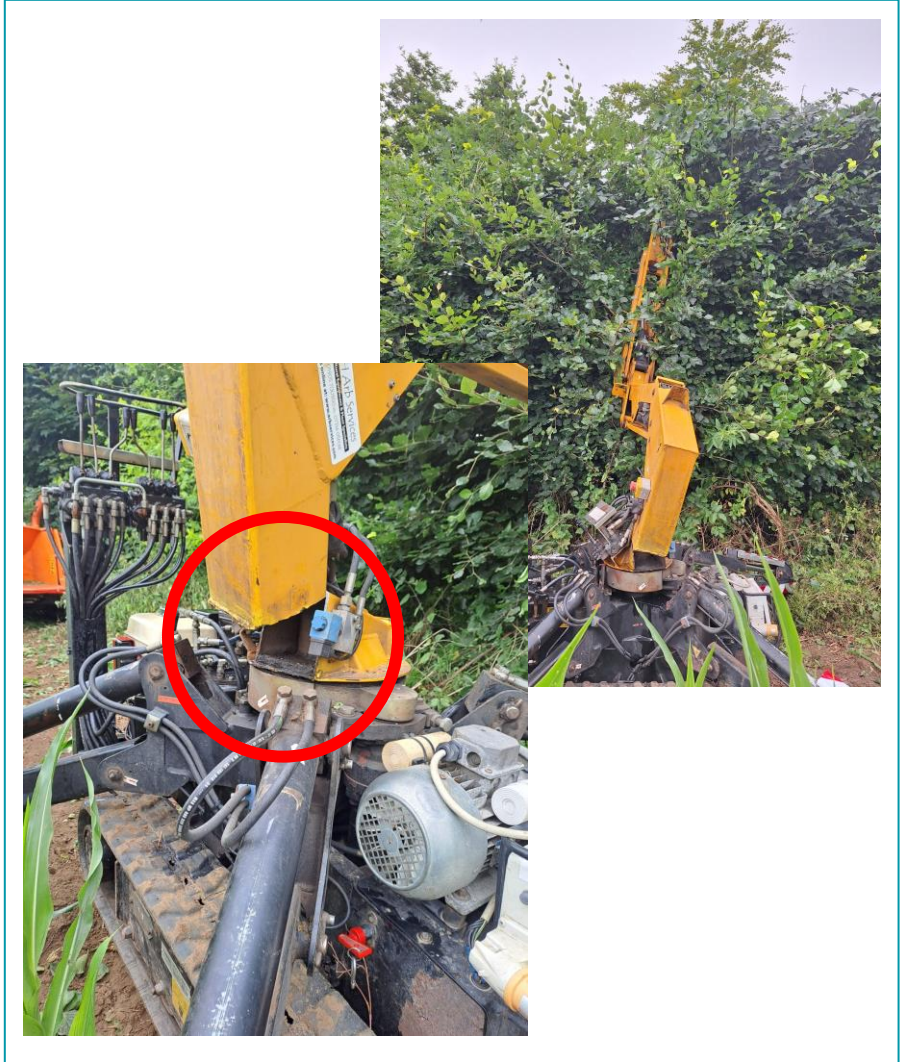
Date of incident	5 th July 2024		Directorate	Operations SEPD	
Region	Works Delivery	Location	Abingdon	Classification	RIDDOR
What happened ?					
<p>Whilst operating a spider MEWP for tree clearance works, the base of the boom failed. Fortunately, the metal fractured slowly, meaning it was a gradual failure. The boom fell into the mature hedge the team were reducing under the line, which has significantly reduced the severity of the impact. The operative was wearing appropriate fall arrest equipment and managed to escape without any injury. Spill kits were deployed to absorb a small amount of hydraulic fluid from one of the hoses. Full investigation ongoing.</p> <p><u>Things to Consider</u></p> <ul style="list-style-type: none"> • Continue to complete daily plant checks • How familiar are you with the plant you are using? • Ensure all plant being used is within LOLER inspection dates
