SOP 437 UPDATE – ABB / HITACHI ENERGY VUBB ON-LOAD TAP CHANGER

This Technical Express supersedes EXP-11-333.

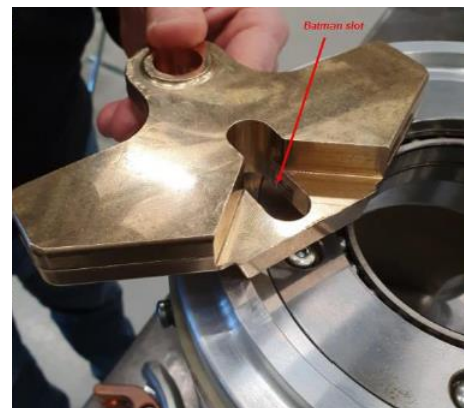
Inspection of the returned Conwy T1 tap changer revealed additional evidence suggesting interference with the internal mechanism of the tap changer (ie. scratch marks found due to misposition of change-over selector actuator, "batman" piece) at the transformer factory. Quality control records confirmed the tap changer required intrusive works at the transformer factory. The addition of this factor allowed a similar failure mode to be replicated in the full-scale tests. No quality control records were found for Llandyrnog T1 but the similarities are significant.

Change-over selector actuator, "batman" piece

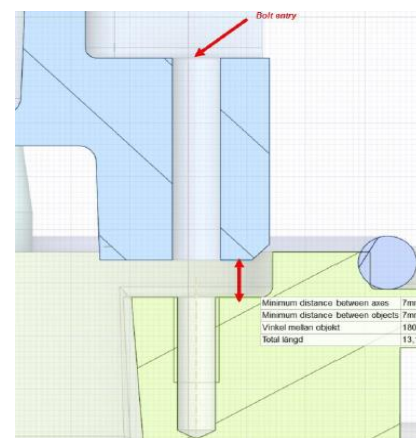
It was concluded that the most likely cause of the failures experienced by SPEN was interference and incorrect re-assembly of the tap changer internal mechanism at the transformer factory, ABB / Hitachi Energy Dudullu in Turkey.

Illustration of gap created by misposition of the "batman" piece which led to excessive force applied when tightening and damage to thread

- Steps have been defined to allow removal of SOP 437 from the updated potentially affected range of transformers. Internal inspection of the VUBB on-load tap changer is required to confirm condition of the internal mechanism fixing arrangements. Methodology for these inspections has been provided by Hitachi Energy. These inspections shall only be carried out by suitably trained personnel.
