As a Mobile Elevated Work Platform (MEWP) was being moved into position the rear arm of the MEWP came into contact with the busbar.

RHIGOS 400KV S/S:
MAIN AVENUE,
HIRWAUN,
RHONDDA CYNON TAFF

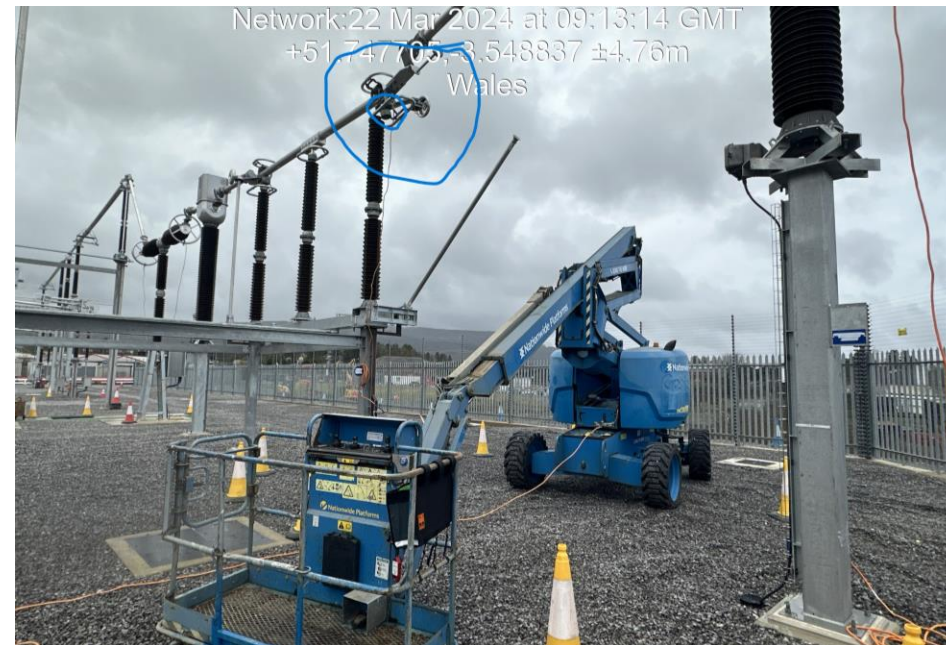
During commissioning works the team were testing the Current Transformer (CT). As a part of these works, test leads were required to be fit at a high level to the CT. As a Mobile Elevated Work Platform (MEWP) was moved into position next to the CT, the rear arm of the MEWP came into contact with the Busbar between CT1 and Disconnector X293 (Blue Phase).

This has caused the head of the top stack on the disconnector to come partially away from the porcelain.

The area was made safe and an investigation is underway.
