## MEWP Incident

### North Wales Incident – 8<sup>th</sup> March

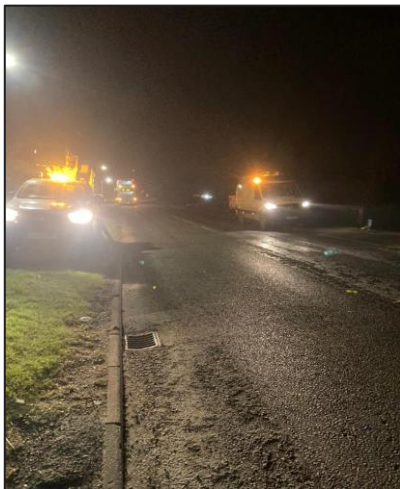
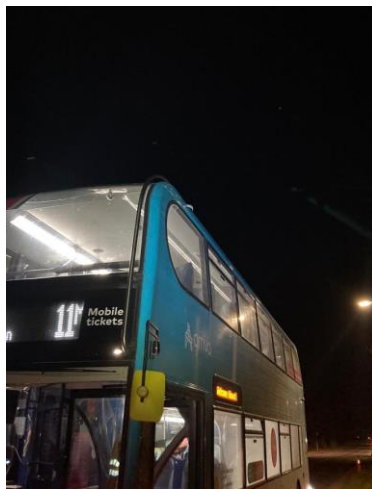
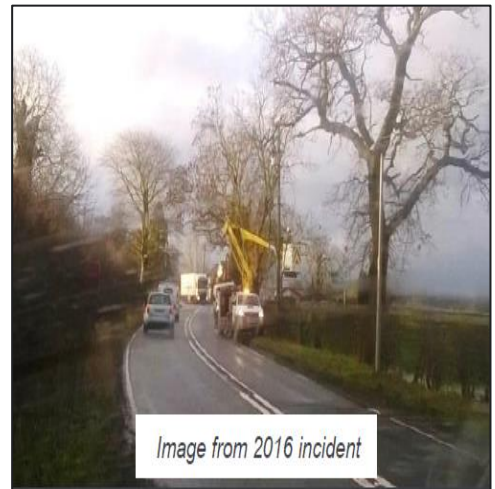
On Friday 8<sup>th</sup> March around 20:30 in North Wales, whilst removing an LV back feed, the boom of an operational SPEN MEWP encroached on to a live carriageway coming in to contact with a bus causing slight damage, there were no injuries.

The MEWP was positioned on a grass verge adjacent to the carriageway, however, during operation, the boom slightly encroached on to the carriageway. No traffic management or lane closure was in place.

- Ensure work is planned properly and Setting To Work considerations are understood by everybody. For example, consider access and egress arrangements, duration of the task, the appropriate method for Working at Height, will the proposed method of work introduce other risks, traffic or pedestrian management requirements.
- Ensure that all risks are considered and appropriate control measures are put in place. Consider risks which can arise from our own activities, service partners, members of the public or other third parties.
- Remember the H&S Essentials:
  - We only undertake work we are competent to do
  - We think before we act assess and control the risks
