SHE BRIEF

Fall From Height

Key initial learnings to be shared more widely

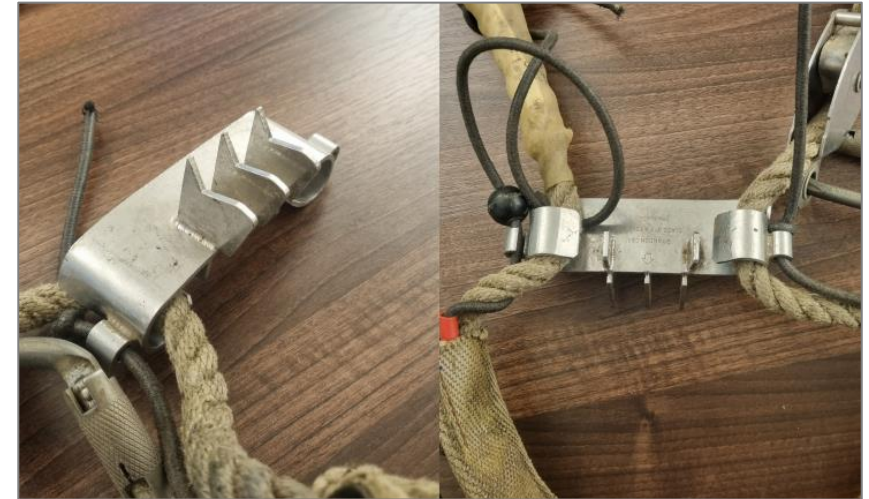
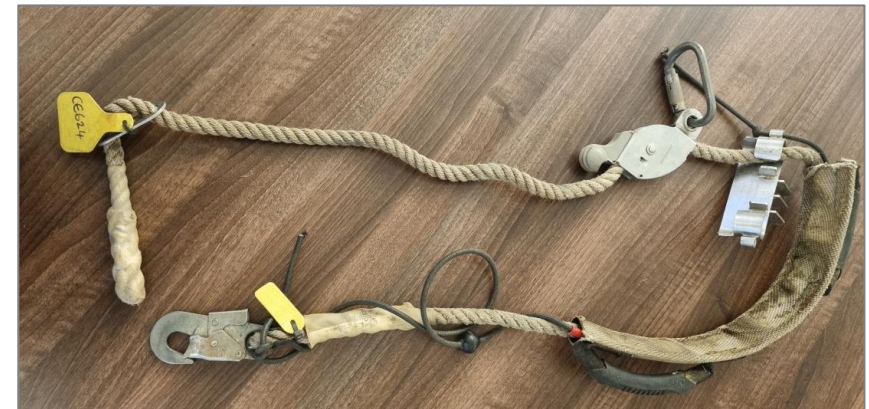
- The pole being worked on was only accessible by foot. MEWP access was not possible.
- All fall arrest equipment used by the IP was LOLER compliant, and in a serviceable condition with no defects or damage.
- The IP's Climbsafe was deployed around the pole when the IP was recovered after the fall.
- The pole did not have snow or ice on it. Green weathering was present – which is common and would make the pole slimy to touch – however this would not impede the Climbsafe from engaging.
- No obvious identifying marks were present on the pole that show where the Climbsafe might have temporally engaged and then failed.
- There is no evidence that the choker has been engaged in a fall, as there were no deviation or twists to the choker gaff, nor was there damage to the bungee cord.

- The investigation has concluded that the likely root cause of the incident is that the Climbsafe was not adjusted sufficiently enough to arrest the fall.
- To remain effective, the Climbsafe requires constant adjustment during both ascent and descent.
