# SHE ALERT

## Toppled Excavator

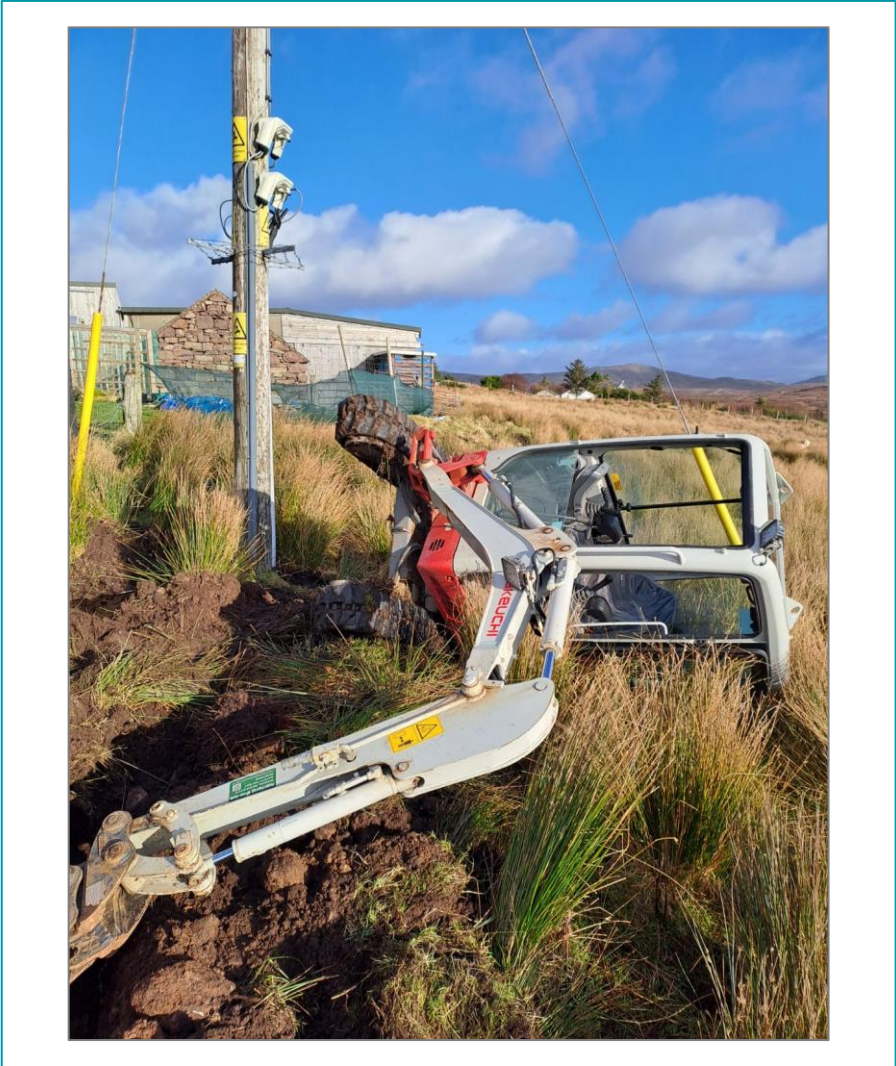
Date of Incident	06/02/2024		Directorate	Operations SHEPD	
Region	Highland & Islands	Location	Gairloch	Classification	PTBW
What happened ?					
<p>Our colleagues were in the process of excavating a track to enable the installation of a mains LV cable.</p> <p>Ground conditions at the time were quite soft due to recent rainfall, and the site was on a slight incline. The excavator operator had excavated approximately 35m of the track when the incident occurred.</p> <p>To enable the excavator to continue digging the track to the pole, the operator had to position the excavator at an angle of approximately 45 degrees to the line of the track.</p> <p>In the process of removing spoil, the bucket came into contact with a large stone in the track, causing downward pressure on the rear tracks of the excavator. Due to soft ground and the incline, the excavator has slowly toppled over as a result.</p> <p>Thankfully, there were no injuries sustained or damage to the excavator. Ensure that you plan, scan and adapt to the work site conditions at all times.</p>
