HIGH VOLTAGE CABLE STRIKE

OVERVIEW

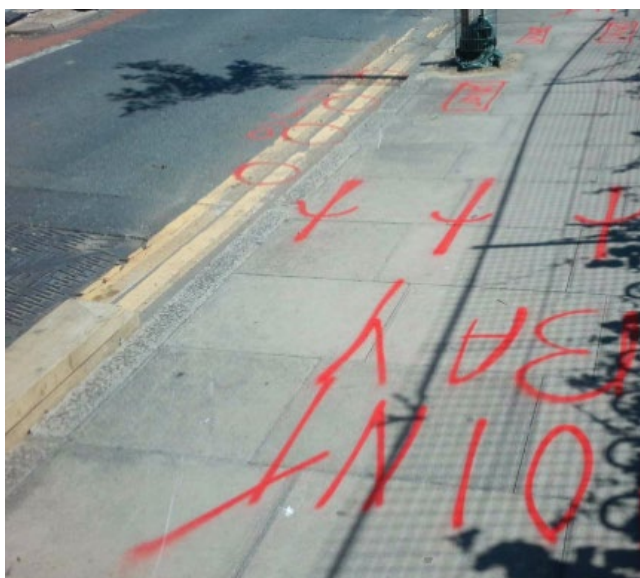
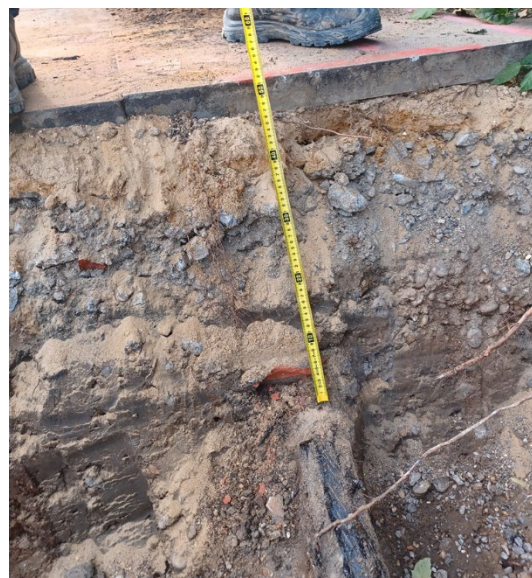
An incident occurred on 14th August 2024 when a High Voltage cable was struck during excavation works. The cable was positioned beneath a lean concrete mix and was struck when a breaker attachment was used during the digging activity.

Upon removing the slabs, the team neglected to re-mark the utility positions and encroachment lines. As they began to excavate, the team encountered a lean concrete mix layer and decided to break up this layer using a “pecker” breaker attachment on the 1.5 tonne excavator.

During this process, the breaker struck a high-voltage cable that was approximately 150mm below the lean concrete mix. Fortunately, nobody was injured, and a serious investigation is underway to determine the root causes.

- Along with plans, use a CAT & GENNY to scan the area for buried utilities.
- Mark out the buried utilities and ensure all marks extend at least 300mm beyond the excavation zone. Take a photograph of the markings and save it to the job.
- Hand dig trial holes to confirm utility depths. Take a photograph of the hand dug trial hole and save it to the job.
- DO NOT use mechanical excavators within 300mm of a known utility.
- If utility and encroachment markings are disturbed, covered or removed, all work shall stop, and the markings be reapplied.
- Refer to DSR 01 014 and HSG 47 for more information on safe digging techniques.
