Catastrophic Failure of a 132kV Cable Sealing End

This bulletin is to raise awareness of the inherent risks associated with equipment failures within an operational high voltage substation.

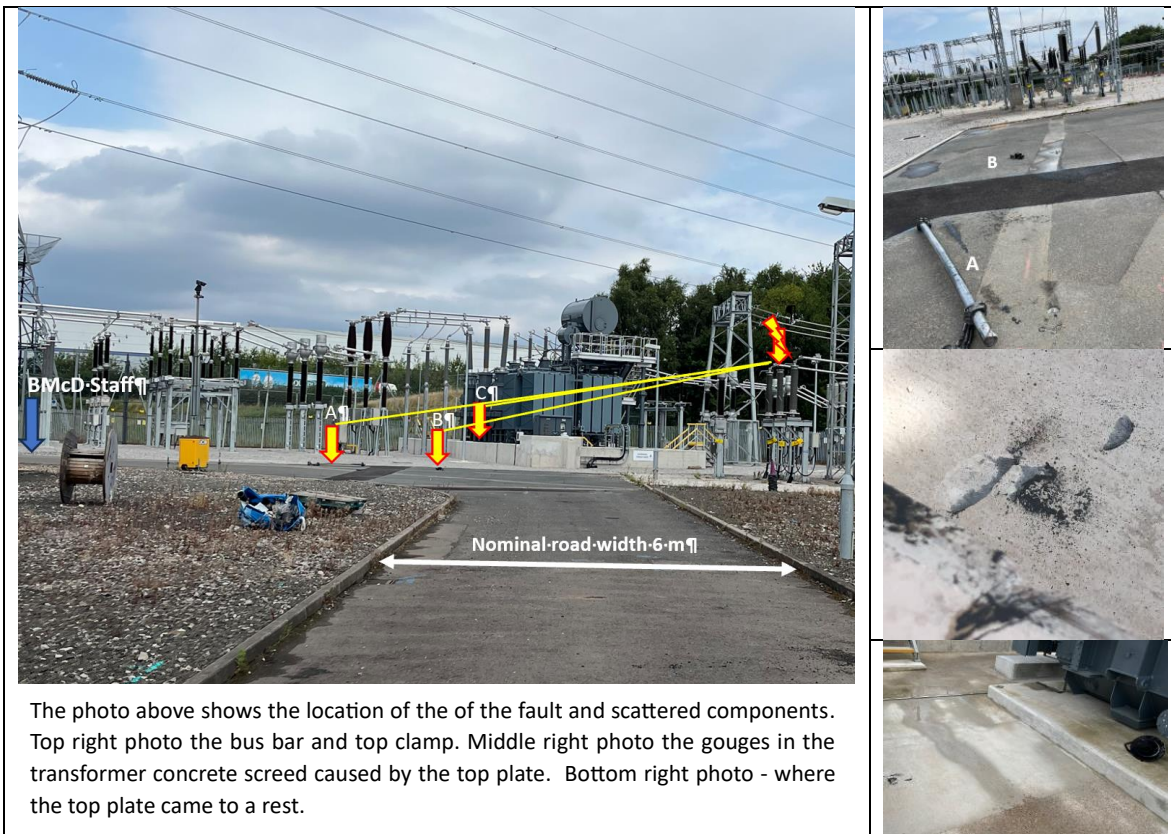
Whilst working at Oldbury substation two Burns & McDonnell staff members witnessed a catastrophic failure of a 132kV cable sealing end. The energy released under the fault conditions was sufficient to cause an explosion, heat from which was described as a fire ball and the top plate of the cable sealing end, the bus bar clamp and bus bar to propel a considerable distance (approximately 20 metres) - as shown in the photographs below.

There was no prior warning of the impending failure (no visual indication, no noise, or smell). The first sign was a loud bang followed by a fire ball and then the clatter of the components as they were scattered around that area of the substation. Fortunately, there were no injuries suffered as a result of this event.

Note: had this cable sealing end been manufactured out of porcelain and not composite rubber, the resulting projectiles would have been far more numerous and presented an even greater potential danger.

The photo above shows the location of the of the fault and scattered components. Top right photo the bus bar and top clamp. Middle right photo the gouges in the transformer concrete screed caused by the top plate. Bottom right photo - where the top plate came to a rest.

Practical safety measures are to adhere to safety clearance distances, respecting the potential dangers of electrical equipment and limiting exposure of working in the proximity of energised equipment; leaving the area when there is no such requirement. It is also a reminder of the importance of wearing the correct PPE, fully and properly.
