SHE ALERT Cut Finger

Date of incident	02/10/2024		Directorate	Large Capital Delivery	
Region	SEPD Delivery	Location	Pyestock Substation	Classification	MTI
What happened ?

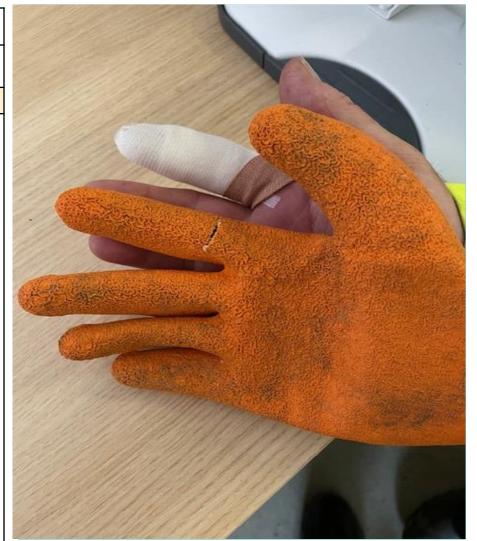
A Contract Partner Employee attempted to manually handle a mild steel road plate from the back of a flatbed lorry and sustained a cut to his right index finger from a burred edge. The Injured Party was given first aid on site before attending hospital. The wound was cleaned and closed using steri strips and surgical glue. The IP was discharged and returned to site the same day.

- Ensure a suitable and sufficient Safe System of Work is in place for the task.
- Manual Handling tasks must be risk assessed and the **TILE** acronym considered Task, Individual, Load and Environment.
- Ensure PPE, including gloves are suitable and sufficient for the task in hand.
- Use the method of Plan, Scan and Adapt for all tasks and be prepared to use your Safety Licence, *if it's not safe we don't do it*
