Isolator Failure during an on-load changeover

KINGSNORTH 400KV S/S:
KINGSNORTH POWER STATION SITE,
HOO ST. WERBURG, NEAR
ROCHESTER, KENT ME3 9NQ

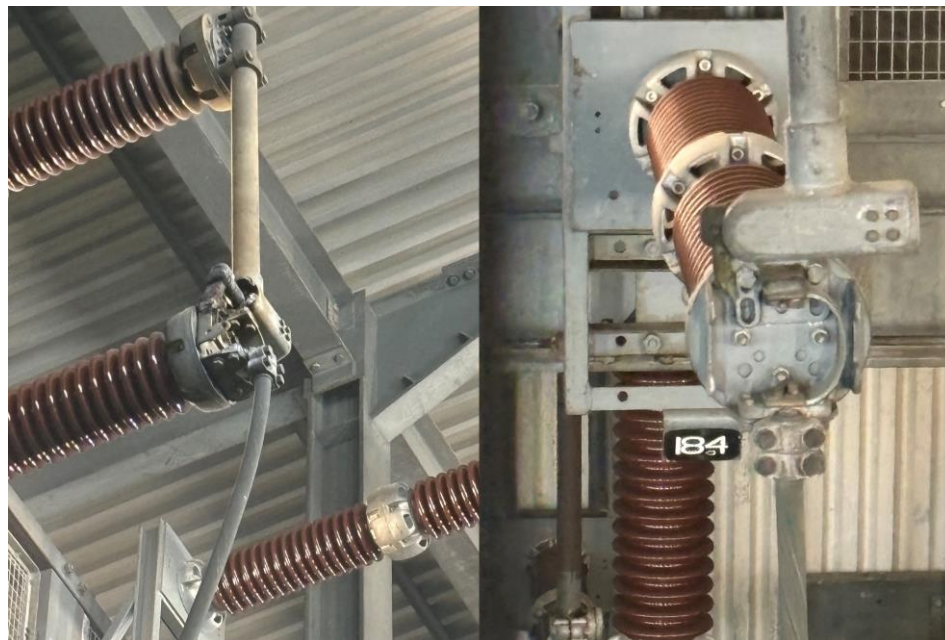
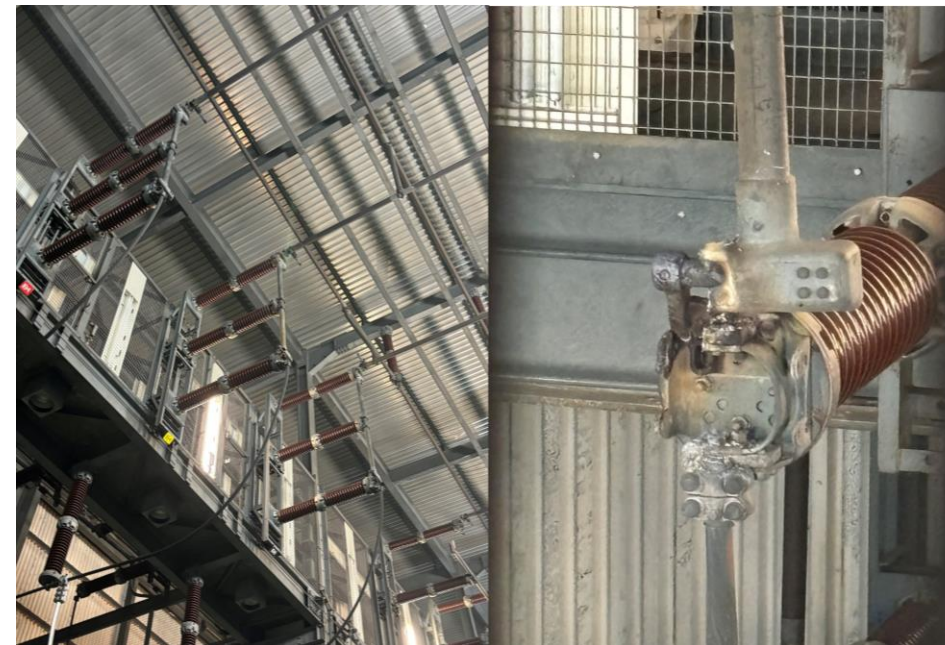
An On-load changeover was taking place when Isolator 184 failed. Due to load current put through the Isolator the centre phase melting the main contacts. No staff were hurt and TNCC operationally switched the Circuit (CCT) out to stop the flow of load current
