SAFETY ALERT!

18/09/2024

Crane Hook Contacted Tower Arm

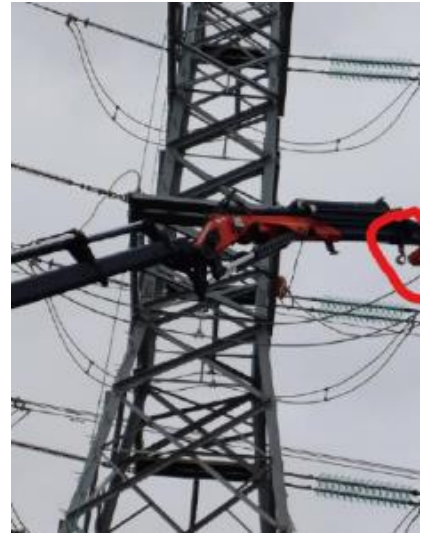
Whilst two workers were ascending inside a man cage, the crane hook contacted the underside of one of the tower's arms and briefly became "latched". As the crane Hiab continued to ascend, increasing pressure on the hook caused it to unlatch, resulting in a jolt to the man cage and caused one of the workers inside to move upward causing a minor scratch to his arm. There was no risk of falling from height as both workers were wearing harnesses.

The hook was surplus to requirements for this operation, having been used previously and should have been removed.

There was an inadequate risk assessment in place to identify the necessary risk controls for the removal of the lifting accessories on the crane Hiab.

Workers requested the Crane Operator to immediately lower them to the ground to remove the crane hook and carry out a Stop! Think! process to ensure everyone was able to continue with the task safely.

Ensure a sufficient risk assessment is carried out to determine if lifting accessories are required.
