Safety Alert

Orion

SA2408 - Incorrect Service Main relocation

11/07/2024

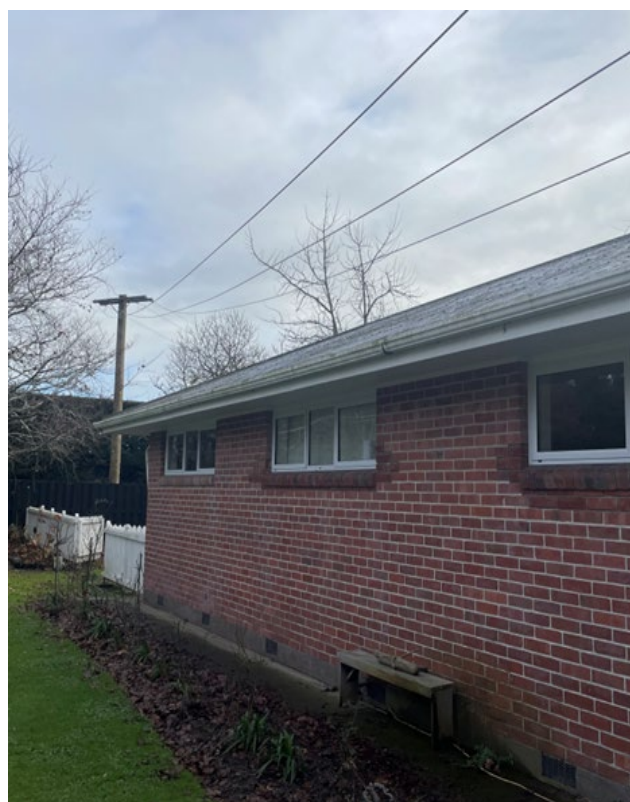
A hard wood low voltage (LV) service pole had to be replaced due to significant rot at the base. In discussion with the property owner the new pole was relocated due to existing trees and with the intention to future underground the final service span to the dwelling. The remedial work for the new pole resulted in the new LV overhead line location inadvertently reducing the overhead LV line clearance to the roof of the dwelling. This has caused a breach with the requirements of NZECP 34. (Minimum Approach Distances). NOTE: This relocation also has potentially no easement, where previously it was covered under existing rights.

- Send this Safety Alert out to your people.
- Communicate to your teams the importance of managing the risk of customer expectation versus safe outcomes.
- Always consider during the planning stage, the impacts that even slight changes may have on dwellings or other structures in close proximity to where the new line route will take.

- Sharing with industry for awareness and learning.
- Proactively working our service provider/s and the property owner to remove the LV line breach / configuration.
- Communicating with our service providers, to consider the learnings from this incident and assist Orion in lifting the bar to remove recurrence of such events.
