FIRST ALERT

27 May 2024

EWP Operator without current competencies

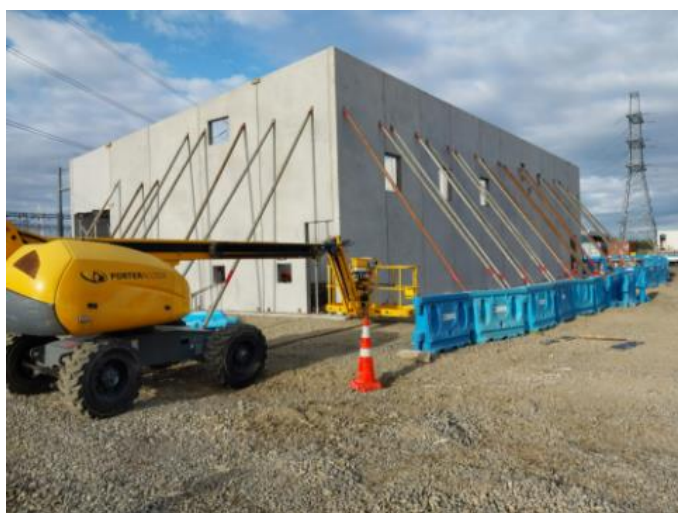
During an inspection while installing pre-cast panels at the Otahuhu STATCOM project, it was identified that the experienced EWP Operator’s competency for the machine had lapsed. The Site Manager was not aware that the competencies needed to be refreshed every 3 years, as indicated in section 6.3 of the MEWP Best Practice guidelines.

It is important to ensure that competency requirements are refreshed as per the guidance to inform operators of potential changes in technology, legislation, and current best practice.

The work was paused, and it was requested that the Operator refreshed their competency prior to operating the equipment again. Another Operator with current competency must operate the machine or the work pause to continue until this refresh occurs. Activities resumed after 40 minutes with an alternative Operator, after their competencies were verified.

- The team was instructed to pause the work.
- The team met and a toolbox was held where they were informed about the importance of having the appropriate and current competencies for the development of an activity.
- An alternative EWP Operator was requested by the contractor. Once on site, the competencies of the new Operator were verified.
