TRANSPower

# SAFETY! ALERT!

## Incident Description

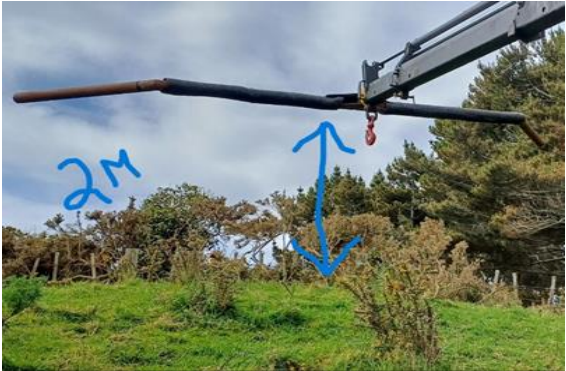
While the Hi-ab crane operator was using his remote control to raise the bullhorn, it failed when it was approximately 2 metres from the ground. The bullhorn was positioned at the rear of a crane truck, connected to the crane's Hi-ab extension arm. The surrounding area was cordoned off, and no one was inside this exclusion zone when the bullhorn failed.

The bullhorn structure was not certified or rated. Pre-use visual inspections were not sufficient to verify the strength and integrity of the equipment.

The height at which the Bullhorn failed and dropped to the ground

Ensure all relevant rigging equipment is certified and or rated correctly and scheduled inspections take place.

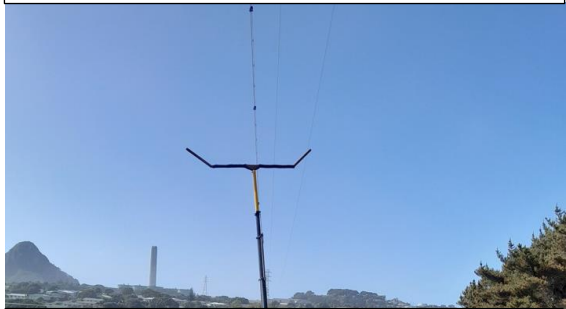
Bullhorn in operation
