Harness Failed During Rescue Training

A Line Mechanic was attending a training course and his harness failed whilst on a concrete pole simulating a rescue.

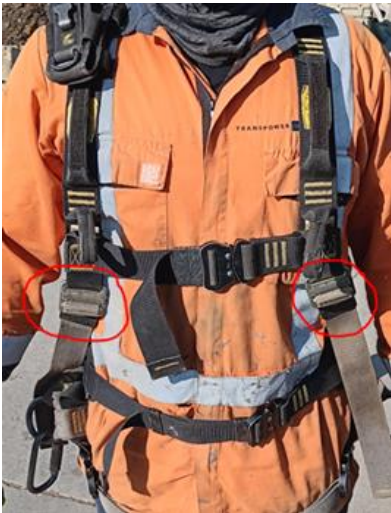
The rescuer clipped the worker's harness to the rescue equipment and removed the worker's pole strap when the worker's harness failed. The failure occurred in both latches on the straps that connect the back and front of the harness.

Figure 1 – Latches position highlighted.

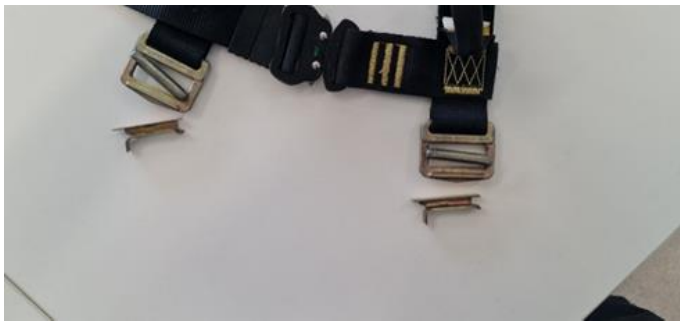
ZERO branded harness, model HTP1679, serial number 23062285. Date of manufacture: January 2023.

Figure 2 - Failure of the latches on the straps of the harness.

Do not use any ZERO branded Tower Harness, model SKU: HTP1679SML-HTP1679UNI-HTP1679XXL manufactured between October 2022 and February 2024. There is a safety recall due to an assembly error of the shoulder strap adjustment buckle on the harness. If the product falls within these manufacturing dates, please return it either to the place of purchase or the manufacturer for inspection.

All harnesses of this type should be closely inspected prior to use.
