FIRST ALERT

Maximo: INC 176061
22/10/2024

WDV-PSUP2-Battery Cell Failure

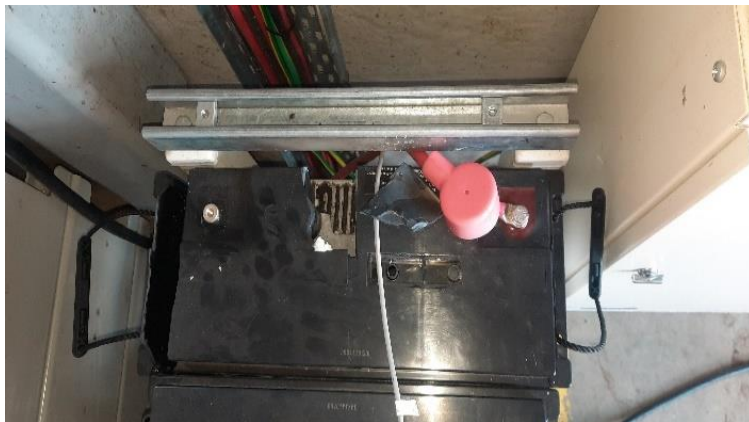
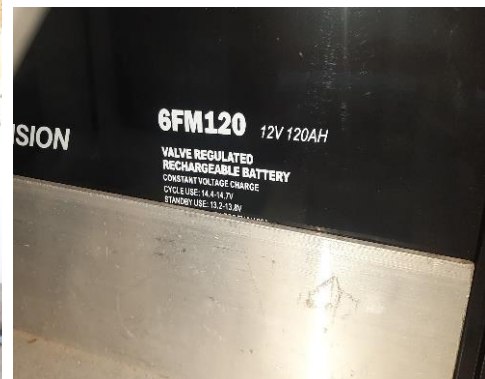
During scheduled maintenance, approximately 1 hour 30 minutes into the discharge test, a battery cell exploded causing small pieces of plastic to be ejected.

This did not result in harm to staff or any associated plant or equipment. The scheduled activity was to complete, acceptance and performance test BT0031. For lead acid batteries (125V Battery Bank 2), as per SMP-02.71.001.

- Torkel 840 test equipment stopped automatically.
- Prior to entering the battery room, the technician uplifted a fire extinguisher and checked the immediate area for any sign of heat or fire.
- Battery bank 2 was assessed for damage,
- The technician noticed a small amount of vapor was rising from the damaged battery, they opened the doors to ventilate room.
- A spare bank has been made available as contingency for this site.
- Incident reported to management and investigation to commence.
