# **Dropped Tower Bolt**

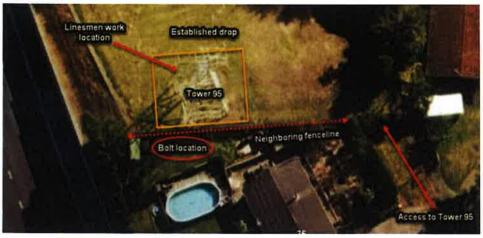
A home occupier was mowing their lawns on a property adjacent to a transmission tower. The day prior, the service provider had been working at the tower. The mower went over a tower bolt, and the bolt then contacted their leg, leaving a mark, and fortunately not requiring medical treatment. The tower was part of a dismantling project. The member of the public contacted Transpower to inform of the incident. Transpower then informed the service provider. The neighbouring property was not included in the Primary Hazard Zone (PHZ) due to site constraints.

- The Line Mechanic who dropped the tower bolt failed to inform their Supervisor which prevented the appropriate action from being taken.
- PHZ management was challenging, with the neighbouring property included in the nominal PHZ, yet the structure itself was not within the property.
- Planning of the work did not effectively account for adjacent properties requiring inclusion within the PHZ.

- Informyour site supervisor or team leader immediately when there has been an accidental drop which has landed in a neighbouring property so that a corrective action can be taken.
- Contact all property owners within the nominal PHZ prior to works, to advise the need to exclude people from the PHZ where objects could fall.
