Acoustic Survey of Overhead Electricity Networks

Goran Stojadinovic, Maintenance Manager, Northpower Ltd

Michael-John Parkin, Electricity Network Asset Manager, Vector Ltd

“EEA Conference & Exhibition 2014, 18 - 20 June, Auckland”

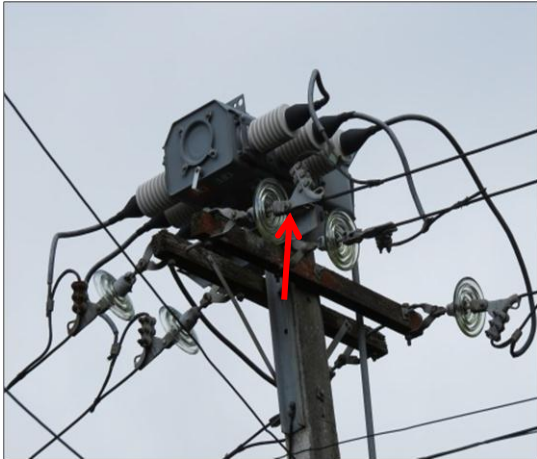
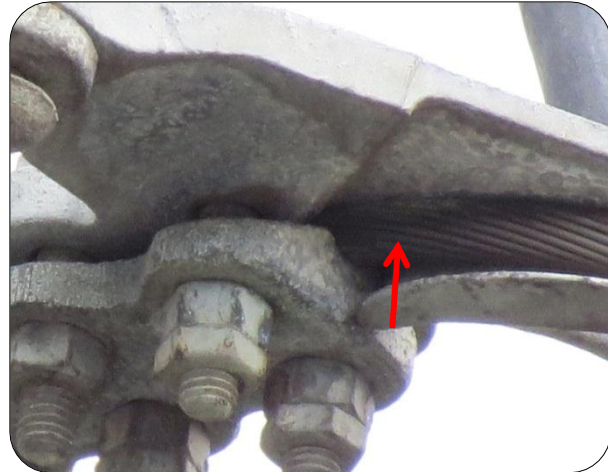
The most vulnerable electrical parts of overhead networks are electrical contacts. Every failure of electrical contacts in the field starts with a gap between two contact points on the contact surface interface, which is the result of “surface films produced by natural aging mechanisms” [4]. It initially creates micro-arcing. As the gap increases, supported by microscopic movement of the interface, it results in more severe arcing between the contact points (electrodes). The arcing creates a sound and/or an ultrasound wave which can be detected with the new acoustic technology.

Fig. 1 Arcing caused by a gap

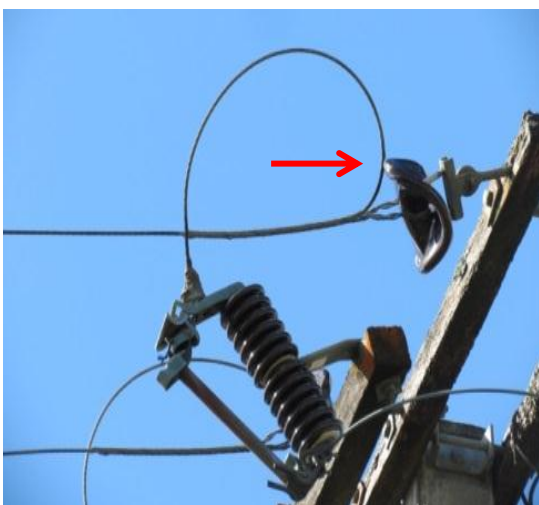
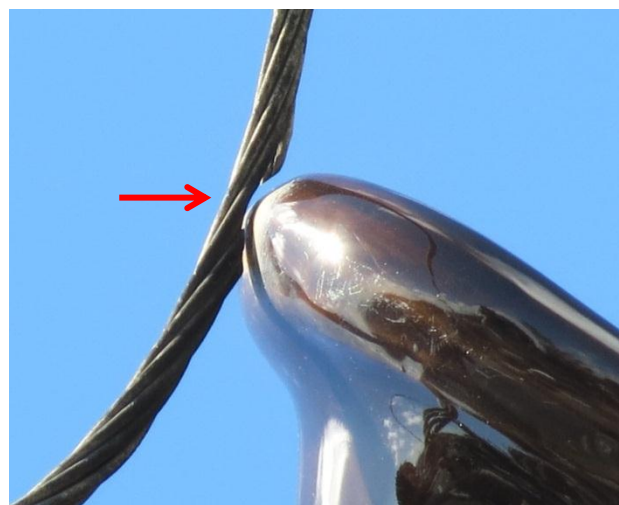
Clearance distance is measured through air. It is the shortest distance between two conductive parts, or between a conductive part and the bounding surface of the hardware. It is affected by relative humidity, temperature, and the degree of environmental pollution. An inadequate clearance distance results in the dielectric breakdown of ionized air between electrodes (arcing), which is detectable with the new acoustic technology.

Fig. 2 Flash-over and heavy erosion caused by a jumper touching insulator

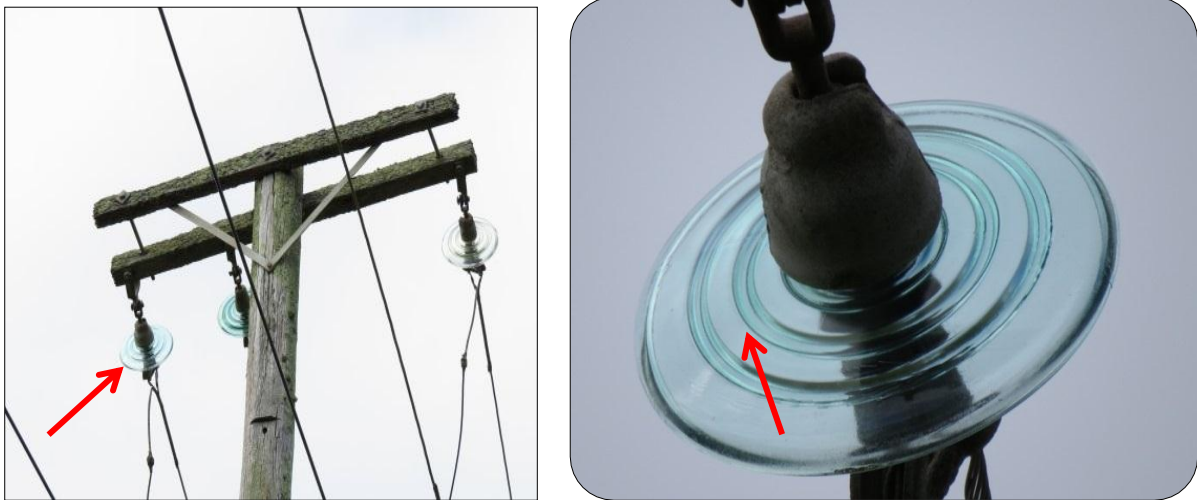
The insulator creepage (leakage) distance is the shortest distance along the insulator surface between the metal parts at the insulator ends. Insulators must provide enough creepage distance to avoid any leakage current from live electrical conductors to flow to the earth through non-electrical hardware. Atmospheric pollution (salt, dust, industrial contaminants) forms a conducting layer on the insulator surface, which shortens the length of the leakage path that could result in a flash-over. Insulator cracks also shorten this path. Flash-overs emit sound which is detectable with the new acoustic technology.

Fig. 3 Flash-over caused by a hairline crack on a glass insulator

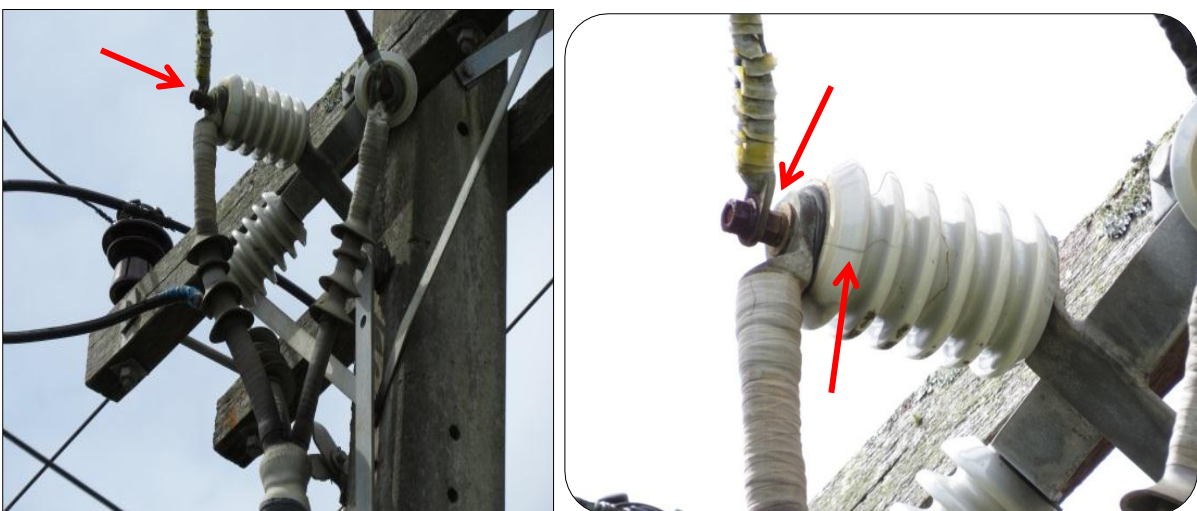
Examples: HV cable terminations - loose contact between lugs which results in arcing and overheating; extra nuts and washers between lugs resulting in rusty connections; air-break switches and other hardware - rusty connections, loose hardware, internal defects

Fig. 4 Rusty nut and washer between lugs resulting in overheating and insulator cracks

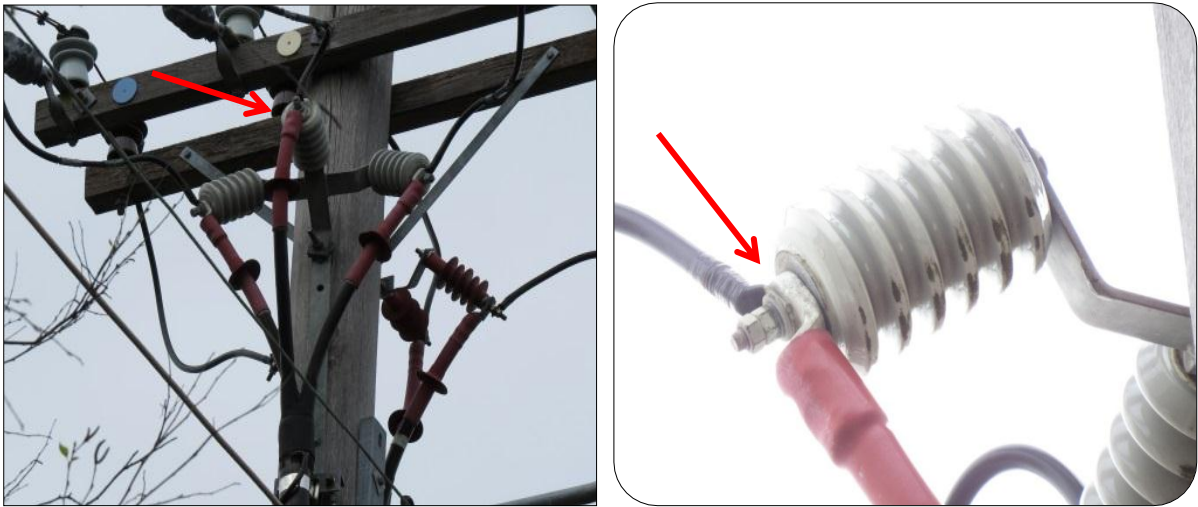
Examples: Al-Cu connections where the aluminium will pit to the copper leaving less surface area for contact.

Fig. 5 Al-Cu connection resulting in micro-arcing and overheating

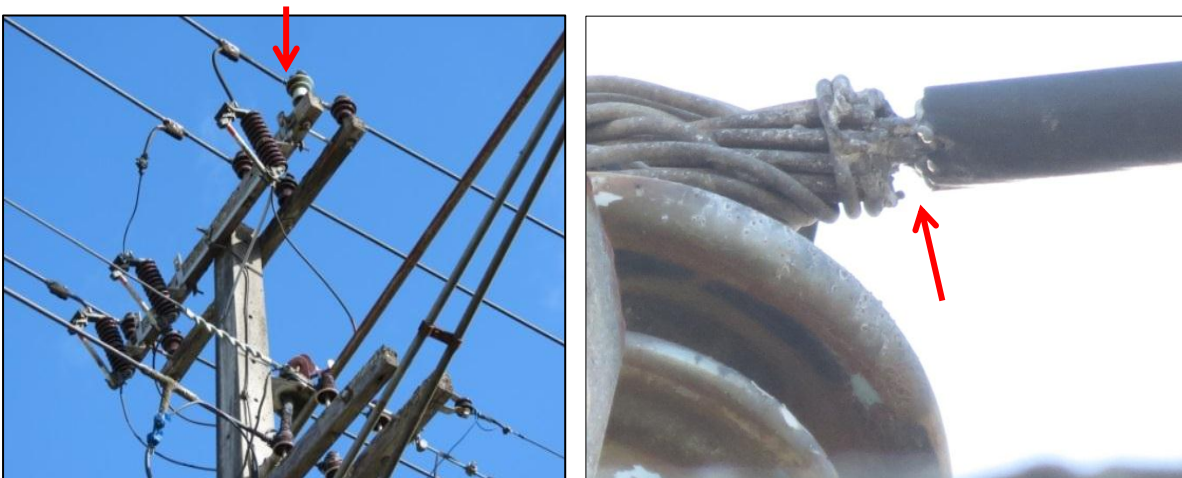
Binding of bare conductor to an insulator should be done with a bare wire (binder) in close spaced spiral around the conductor to ensure good electrical contact. If it is not sufficiently firm and tight, it will result in the development of intermittent contacts. The same will happen if there is any insulation between a conductor and binding wire e.g. insulated binding wire, insulated conductor or both. Intermittent contacts along a binding wire will result in electrical discharge and arcing, which is detectable with the new acoustic technology.

Fig. 6 Bare binder over insulated conductor resulting in el. discharge and heavy erosion

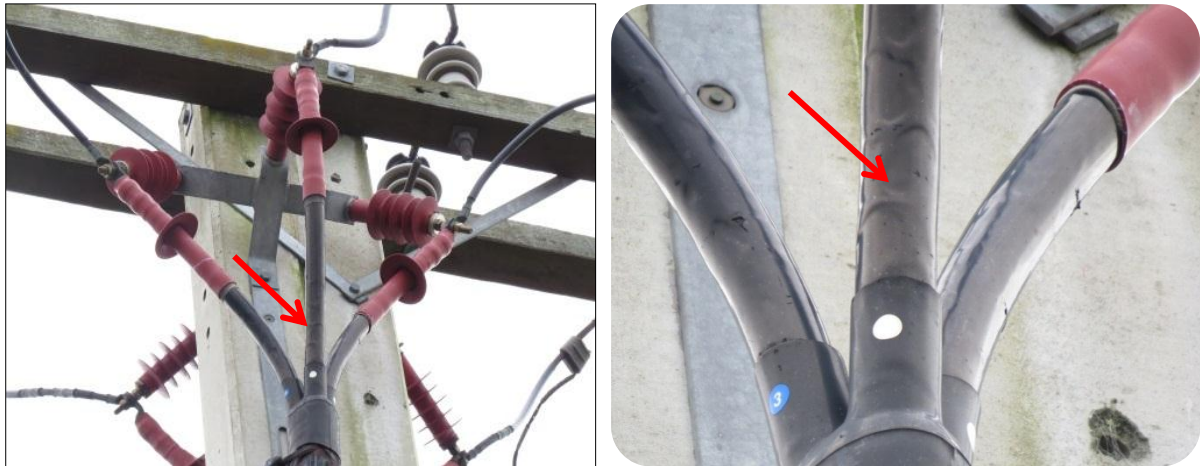
It seems that the discharge can also occur between the insulating layers on a single phase conductor of HV termination, which results in random arcing or sparking. During the recent acoustic inspections, several cable terminations had one phase-conductor emitting ultrasound.

Fig. 7 Suspected PD between two insulating surfaces resulting in random arcing
