# Developing Secondary System Upgrades

A Case Study of the Waitaki 110V DC Distribution Upgrade

Prepared by William Thomas

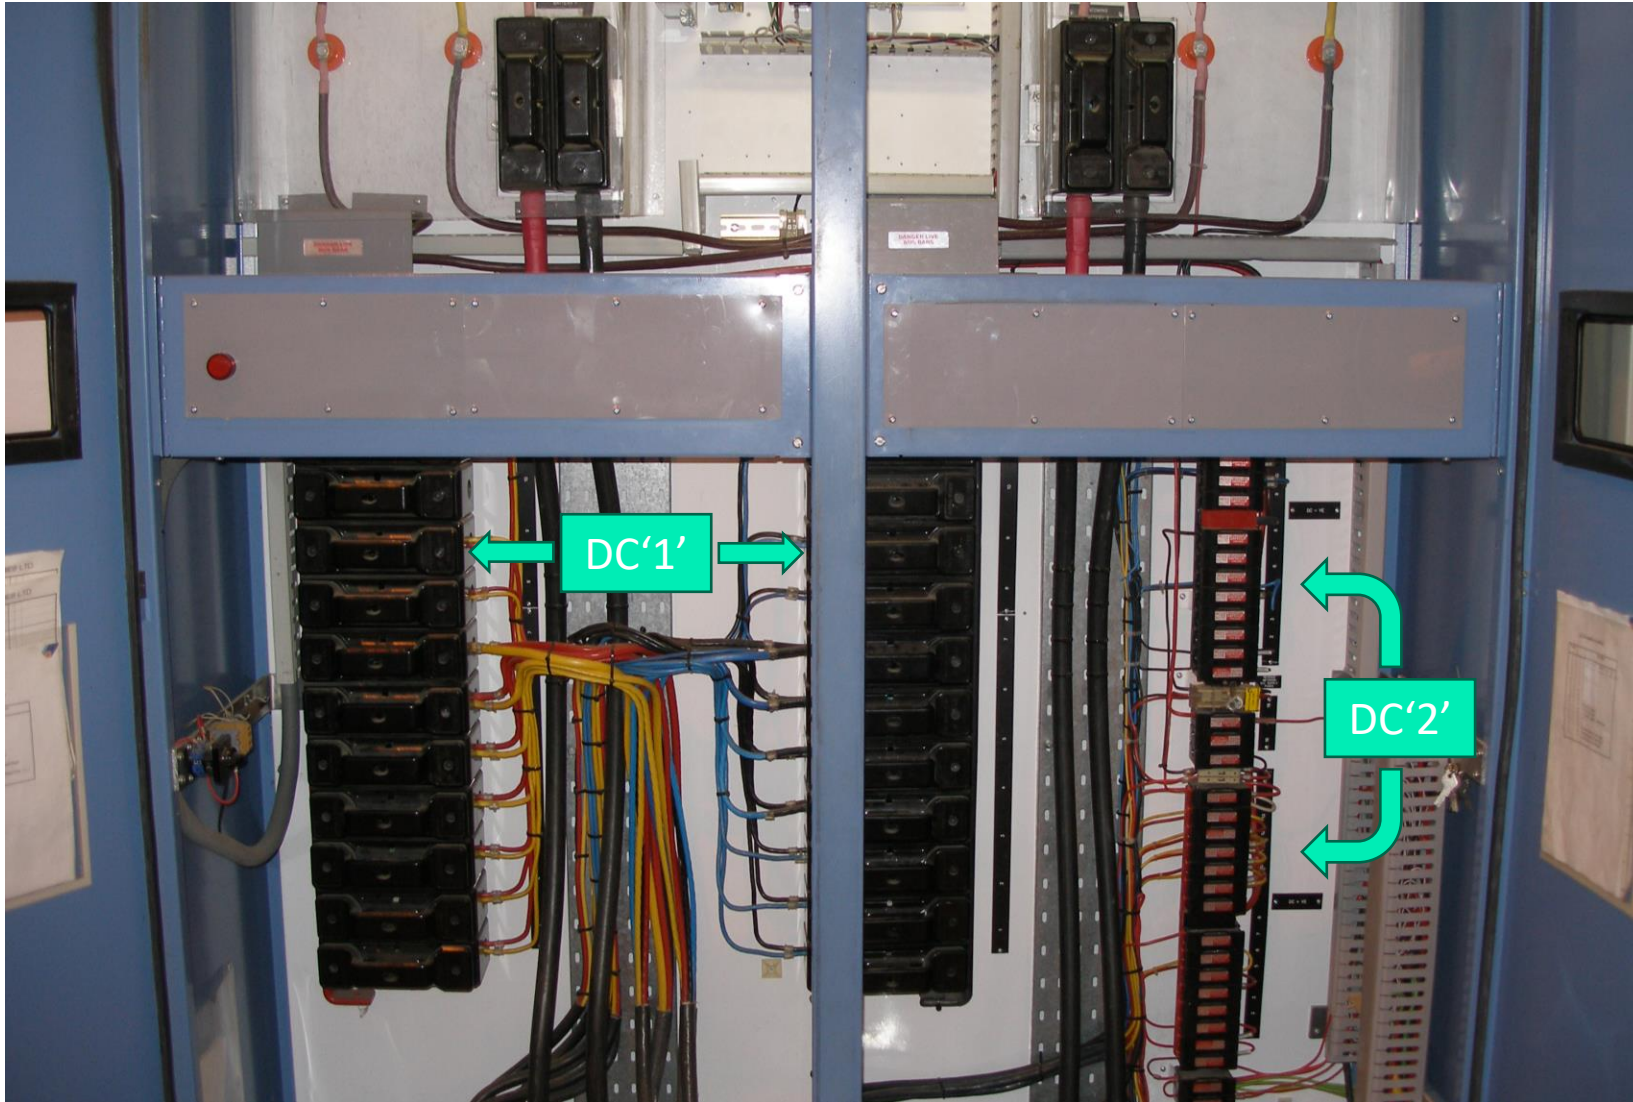
## **WTK 110V DC Distribution - Problems**

Both separate sets of battery banks and chargers are fed through one location.

Wiring layout is confusing and difficult to add new connections.

Supply monitoring is outdated and faulty in some areas.

DC'2' services are supplied from the DC'1' bus.

Documentation is known to be out of date.

The existing PDP is a single point of failure and presents an increased risk of 110V DC loss.

## Design Solutions

Relocate one of the battery chargers to new location.

Segregate out the PDP into four separate cabinets:

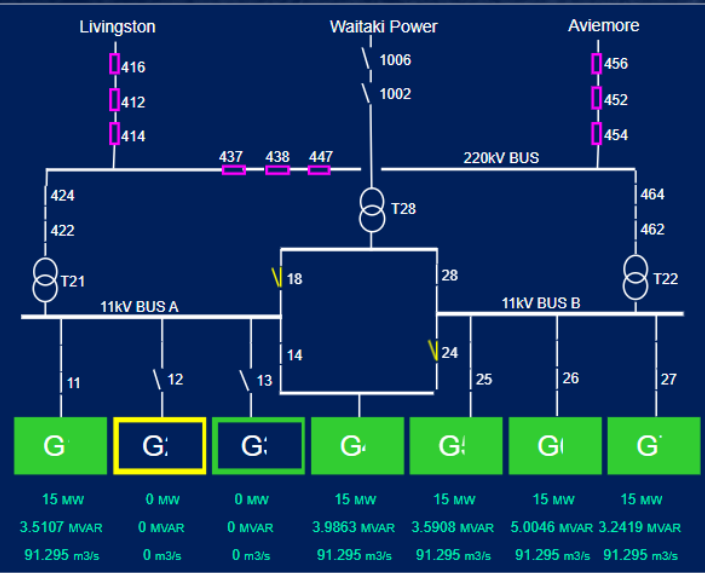
Site Overview 30 seconds before 110V DC failure.

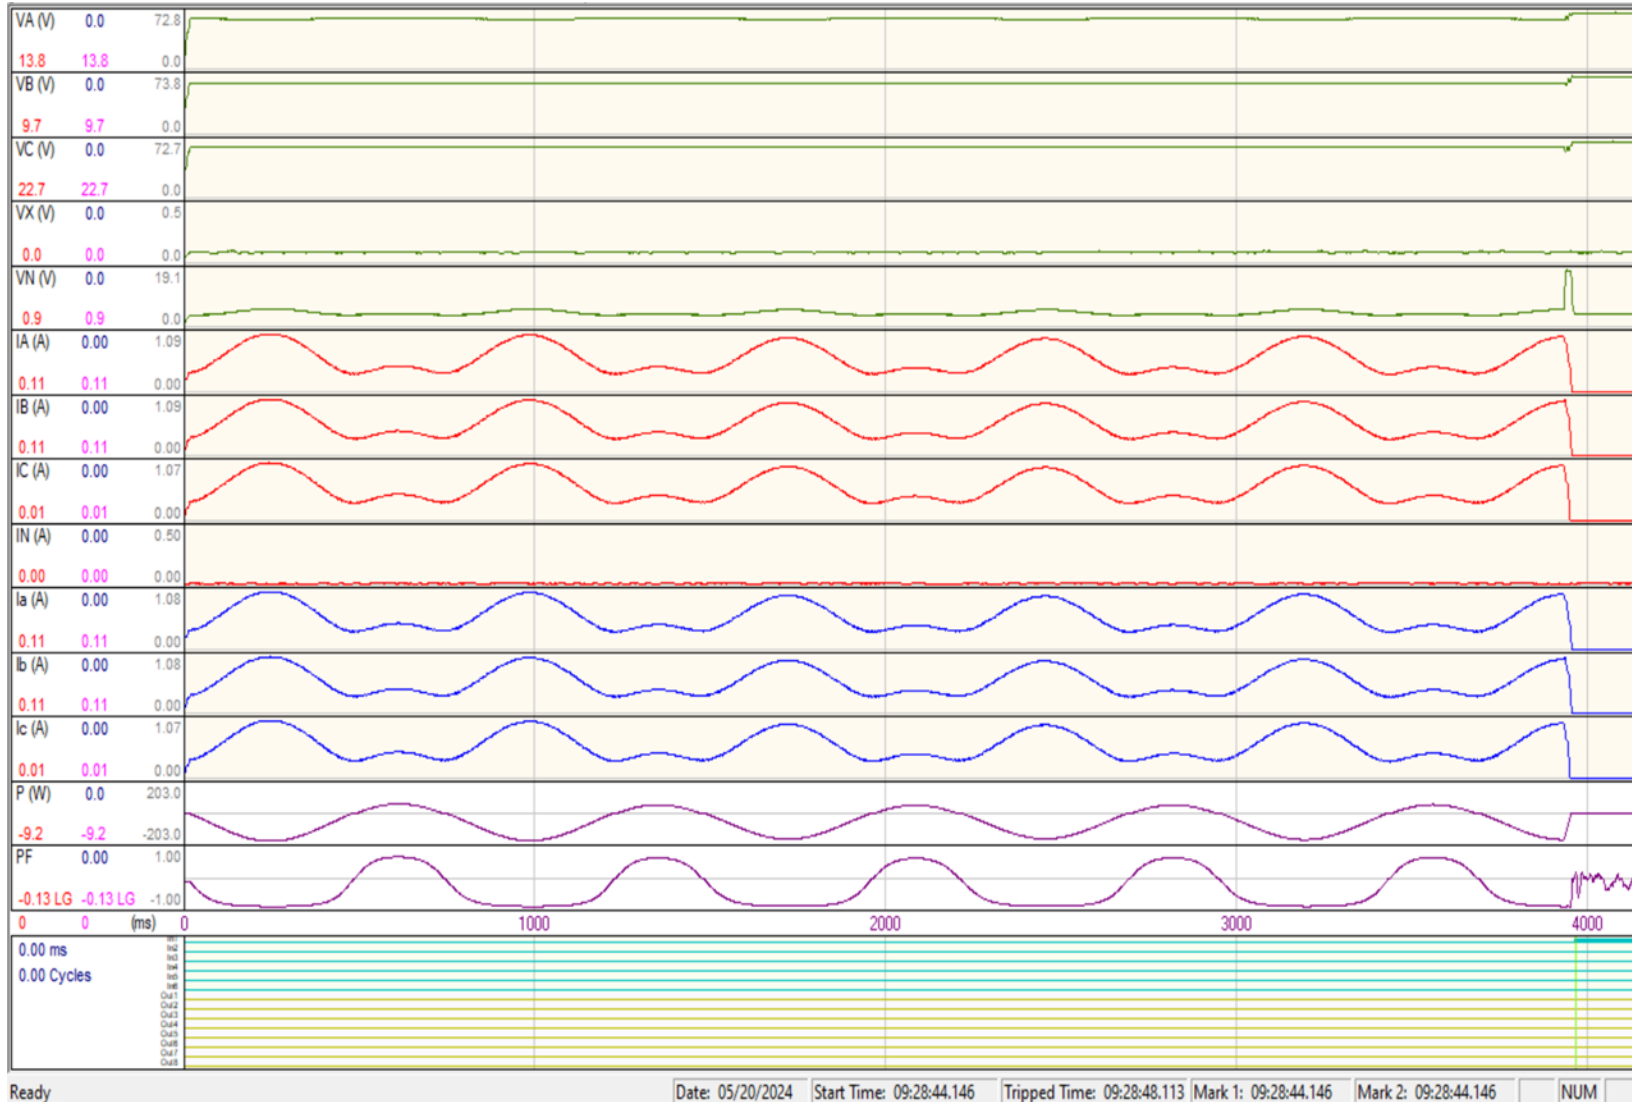
Unit 4 didn't disconnect from the 11kV bus like the other units.

U4 has two 11kV CBs (Bus A and Bus B) which rely on 110V DC powered limit switch indication.

Therefore, the PLC fails to see a closed CB and does not trigger its backup trip.

So, the generator keeps spinning with no driving water flow.

U4 became a motor.

While motoring, U4 became unstable and started pole slipping.

The resultant power oscillations ranged -15MW to +6MW.

Causes of this have yet to be fully understood.

U4 was only tripped once the 110V DC supply was restored (5 min motoring).
