### Worker Received Induction Electric Shock (LL266)

| Incident | | Description |
|---|---|---|
| Event Date: 25/11/2024 | Time: 3.37 PM | Location: Tamarangi Drive, Kawerau |
| NP Reference / External Reference: OCC14660. Maximo: 176449 | | |

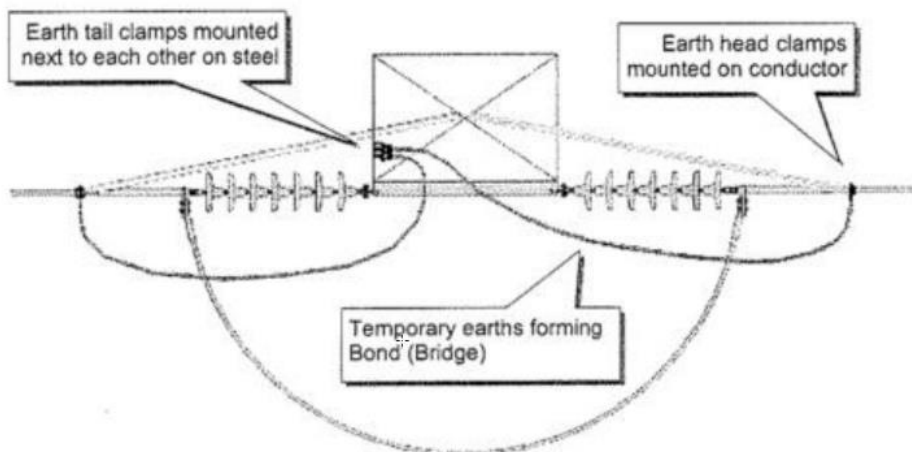
A Northpower transmission lines team was tasked with re-insulating and replacing dead ends on a transmission structure. The team accessed the structure from both sides using man cages. Earths were applied on both sides of the structure, outside the dead ends, forming a bridging bond across the jumpers in accordance with Northpower procedures (see image below). However, the last jumper was incorrectly made and installed at an incorrect length.

When a line mechanic unbolted his side of the conductor jumper to remove it, he received an electric shock. This occurred because the line mechanics working on the opposite side of the structure, under the mistaken belief that the job was complete, had already removed their earths. This action broke the bridging bond across the jumpers, disrupting the equipotential zone (EPZ) and creating a dangerous situation for the line mechanic.

- The earth also acting as a bridging bond was removed out of sequence due to miscommunication.
- EPZ was not clearly understood by the employee who removed the portable earth, with varied levels of understanding within the wider Northpower lines team and potentially the industry.
- Communication issues due to the lack of working headsets available onsite.
- Northpower's Jumper Installation and Maintenance (PEW) Procedure did not include bonding earth directly across the bolted connection as an additional safety measure. And the customer service spec lacked clarity regarding jumper removal and associated bonding requirements.
- The addition of a short bridging bond across the bolted connection would have protected the worker from receiving a shock.

- Northpower procedure was amended to include using a bridging bond between the main conductor and the jumper, directly across the bolted connection, before breaking the jumper and rolled out to workers before work recommenced.

- Recommendation to customer to review and clarify service spec and table best practices when removing jumpers at the National Lines Forum.
- Provide all workers required to work overhead with headsets, an effective storage system and reinforce the use of radio headsets when performing overhead works.
- Engage an industry subject matter expert (SME) to undertake earthing and bonding refreshers on a biennial basis (every 2 years).
