Safety Alert

Employee Cut into Live 11kV cable – no injury

Date: 08/05/25

Vault No. 5440

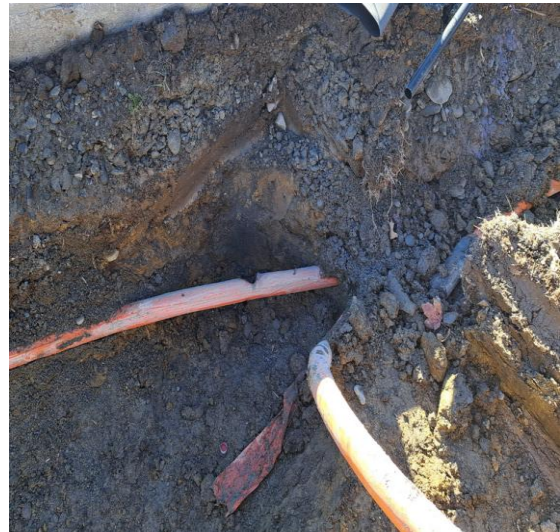
A Connetics employee has cut into a cable that he believed to be a deenergised LV cable. The employee performed the necessary permit recipient safety applied measures to the LV circuit. He tested the ends of the LV cable and proved it to be deenergised. The cable was located at 600mm depth. The actual LV cable was located at 1100mm depth. The cable at 600mm was a live 11kV cable. The cables are very similar in appearance, size and colour.

1. Prior to making any cut make sure the embossing on the outer cable matches what you are expecting to see (or other physical method), and the cable is proved deenergised at the point of the cut via live working methods.
2. Service Plans are not always correct, and cable identification is needed.
3. Cables can be found at different depths due to site specific configurations.
4. If there are multiple services present, contact Network Control and get permission to 'spike' the cable.
5. This event emphasises the importance of wearing the correct PPE as occurred here – dielectric boots, visor, live work gloves & full body cover FR/Cal rated.
