## Failed guy wire assemblies

## ISSUE IDENTIFIED: Broken and corroded guy wire assemblies

Quality Alert REF No: 2025-003

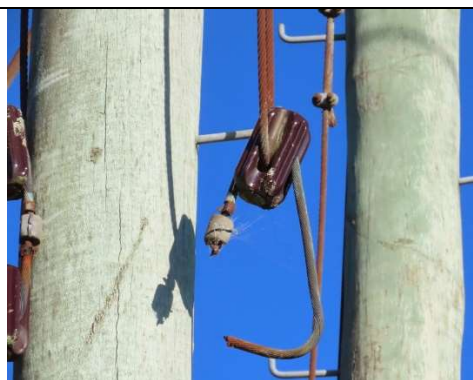
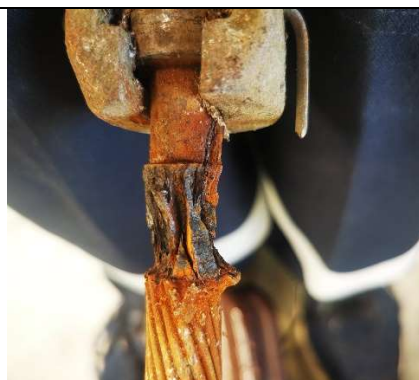
Failed guy wire assemblies were identified during recent Service Provider routine patrol. The guy wire loop assembly connecting the porcelain guy insulators together failed due to severe corrosion.

- A metallurgist's opinion was obtained on the failure of these guy loops (copper clad steel wire loop with galvanized steel ferrules pressed on each end) and they concluded that "a mix of metals is not good. In this case copper will be dominant, causing the zinc and iron materials to preferentially corrode."
- While these are fit for purpose from a design perspective, this is a manufacturer's design dating back to the 1960's that is non-standard today.
- Many of this design of guy loop are reaching end of life, along with other components in the guy assembly (e.g. the guy wire itself), but cannot be easily identified from ground level

**ACTIONS TO PREVENT REOCCURENCE:** Monitor during routine patrol and CA

- Educate staff on the potential issue of broken guy wire assemblies and the potential consequences
- Ensure those performing routine patrols and CA are aware and actively reporting issues identified
- When any component of a guy assembly reaches replacement criteria, the entire guy assembly is replaced with the new, standard design.
- Updates will be made to TP SS 02.98 and MCG-02.98 to add further guidance around guy wire assembly CA

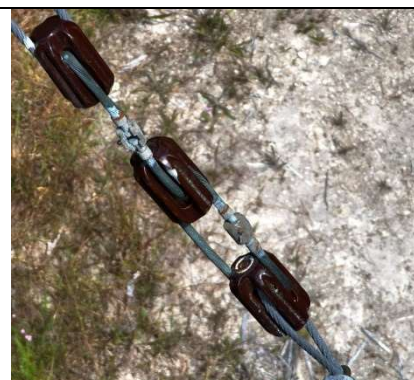
- An older design of guy wire assembly failed due to galvanic corrosion
- Importance of condition assessments and checking other older assemblies – see photo (above right) for example of early corrosion. The rate of corrosion accelerates from this point.
- Inspection at height or with a drone is necessary to identify the extent of the corrosion
