Incorrect Isolation Point Referenced on Permit

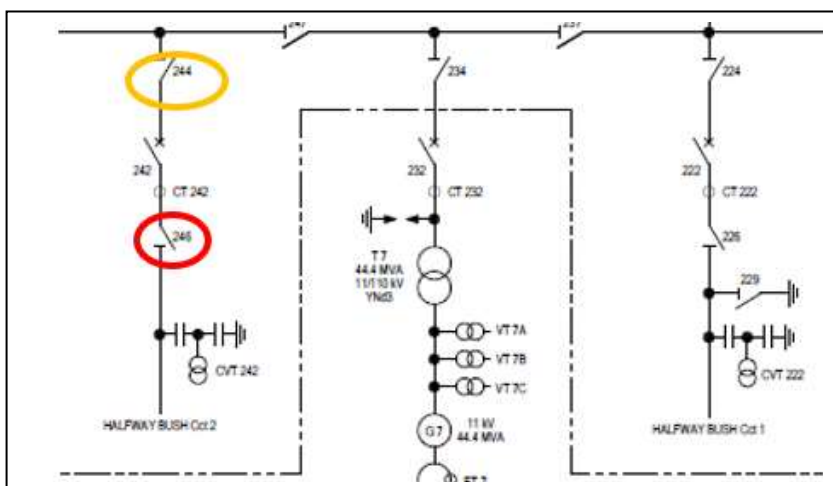
An Operator issued the incorrect permit to a lines team. The issued permit was for later in the week when further switching was to take place after maintenance on 246 was completed. The incorrectly issued permit stated 246 was the ROX isolation point (red circled disconnector on SLD). It should have read 244 (orange circled disconnector). The line was also isolated at the HWB end and the error did not pose any danger to the lines team.

- While preparing to issue the permit to the lines team the building security alarm unexpectedly sounded, distracting the Operator. Disruptions and distractions can contribute to people losing focus, potentially leading to errors being made.
- The two permits were almost identical but referenced different disconnectors and dates. The incorrect dates were pointed out to the Operator by the Lines team and were changed on the permit but this did not trigger a “Take 5” by the Operator to find out why they were wrong (complacency).

When carrying out safety critical tasks, any time a person is distracted/loses focus, or finds any details on the permit incorrect, they need to stop, take 5 and recheck and confirm all the details are accurate before continuing.
