Safety Notice

Issue 5 | Rev. 0 | May | 2025

MEWP outrigger slip

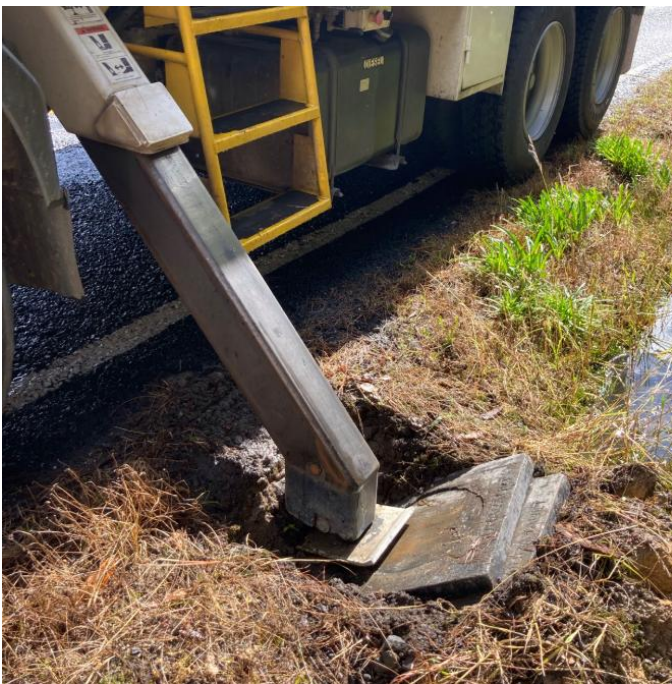
On the 8th April 2025 whilst trimming trees from a MEWP over the side of the truck, the operator has extended the bucket, and the ground has given way beneath the outrigger, causing the bucket to drop (approx 1m) and the roadside outrigger to lift off the ground. No injury or harm occurred.

To meet the CoPTTM requirements for lane closure of 1m clearance between the road cone and the workers, only one outrigger could be placed on the tar-sealed road. The nearside outrigger sat between the edge of the road and the grass berm. Despite the nearside outrigger being positioned on a pad, the transfer of weight and subsequent ground conditions and slope of the edge of the road led to the sudden movement.

- Ensure all MEWP have appropriate outrigger pads and wheels are chocked
- If placement of outrigger is not suitable, change position of MEWP and / or traffic management set up to provide stable outrigger placement
- After set up, fly the boom from lower controls and especially over the outrigger to test the set up
