## SAFETY ALERT

### Strained shoulder

**Event Number:** 158858

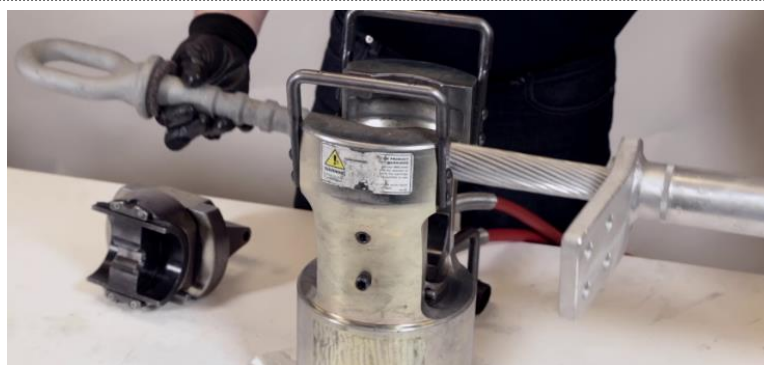
The injury occurred during rigging and termination tasks which involved lifting a 38kg press-head into position in a limited space

- No mechanical assistance was available for lifting the press-head with limited space inside a crane man-cage.
- The design of this task within the crane man-cage requires awkward movement due to limited working area.

Figure 1 - press-head dead-ending conductor joints.

- Increase awareness of manual handling risks and site control measures.
- Use a two-person lift instead of a single-person lift.
