Non-Conformance with AS/NZS 4836:2023

Safe Working on or Near LV & ELV Electrical Installations & Equipment

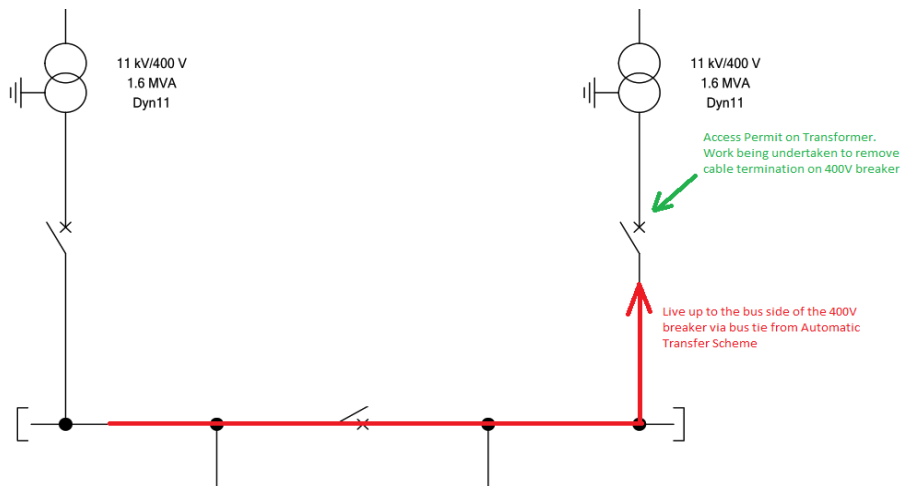
While carrying out planned work to remove an incomer cable from a 400V Switchboard, a previously unknown bus was identified to the rear of the board. Work was subsequently stopped with the bus tested and confirmed to be live via the tie breaker from the other half of the bus. To manage the works, an insulated divider was installed to act as a barrier while the incomer cable was removed. No further protection measures were taken to carry out the task.

The board is 400V and has a fault rating of 27kA, posing a high risk of serious harm to personnel. **AS/NZS 4836:2023** recommends Category 4 PPE (Arc Flash Rating 40cal/cm²) be worn for work on all switchboards >800A. In this instance, workers donned only the Transpower minimum required PPE which is Cat 2 (Arc Flash Rating 8cal/cm²).

In failing to follow the principles, guidelines, practices and recommended safe working procedures as outlined in **AS/NZS 4836:2023**, a section of the bus remained live. Isolating all feeds to the work area, as per the Hierarchy of Controls, would have eliminated the risk, removing the requirement of installing insulated dividers and the need for CAT 4 PPE.

AS/NZS 4836:2023 provides clear principles, guidelines, practices and recommended safe working procedures and should be referenced when planning for and carrying out any work on or near LV & ELV Electrical Installations & Equipment

Given that Transpower has a number of high fault current boards in operation it is essential that all works are planned and managed accordingly.
